**Re: Recommendations for Historic Preservation Compliance, Lockwood Valley Ranch,
Unincorporated Ventura County, California**

ATTACHMENT A: Photographs of Reyes Adobe

ATTACHMENT B: Structural Engineers Report

RE: Reyes Adobe
Silman Project No 3026.0030145

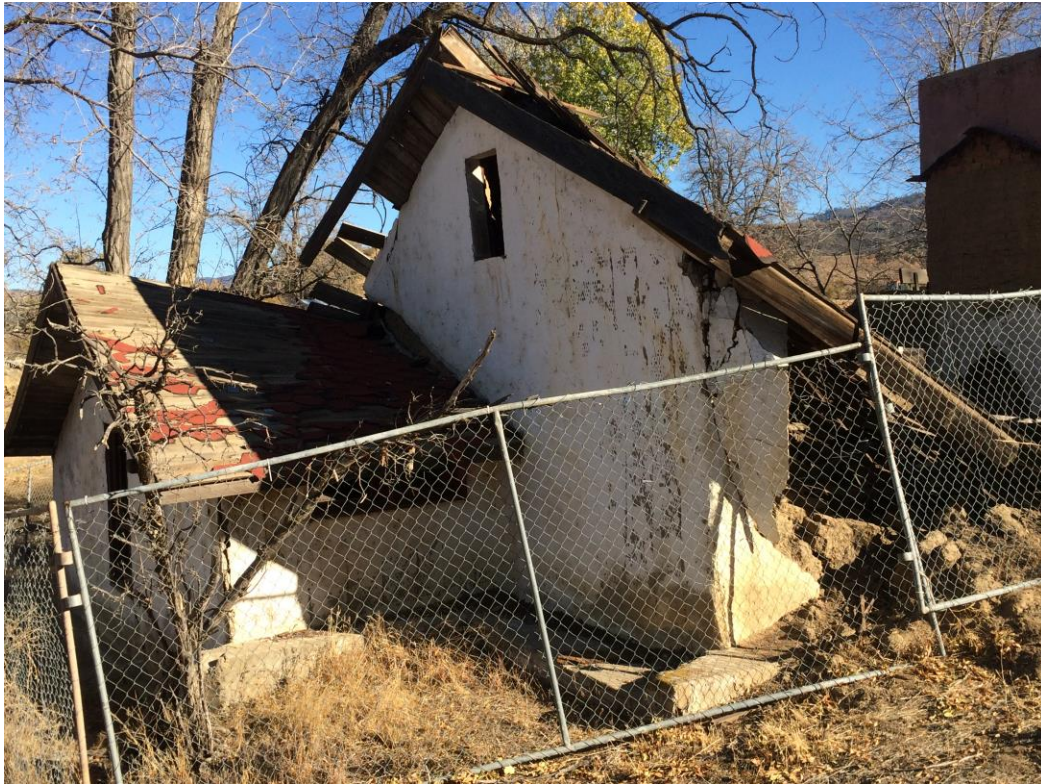
The adobe walls of the later additions to the north are still standing, indicating the original side gable shape of the roof (Figure 12). Portions of these walls have been covered with cement and have the only recognizable fenestration. A one-over-one sash window is located on the north façade and a clerestory window in the upper section of the west façade (Figure 13). Although the central portion of the adobe is mostly deteriorated, a chimney located in the middle of the original section is still extant (Figure 14). Because most of the walls have collapsed, it is difficult to determine the fenestration pattern in this central section. A door was located near the chimney on the east façade, with another on the south end near the two-story building. Historic photographs and assessor records indicate the building had a porch spanning the section from the north addition to the two-story building added in the 1940s (Figure 15).

Figure 12. Detail of addition walls which are still standing, looking southeast.

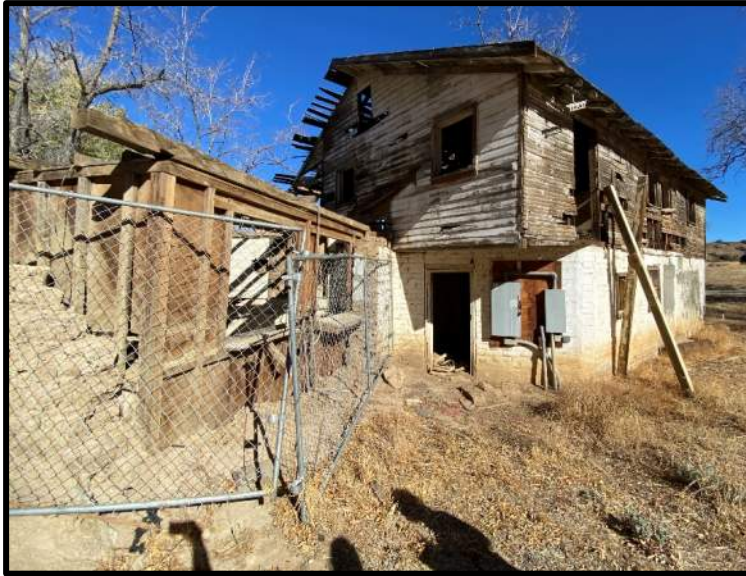
Fencing has been erected around the adobe building to restrict access as the site represents a significant safety hazard in its current condition.

Fence Restricting Access at Adobe Wing (left) of the Building

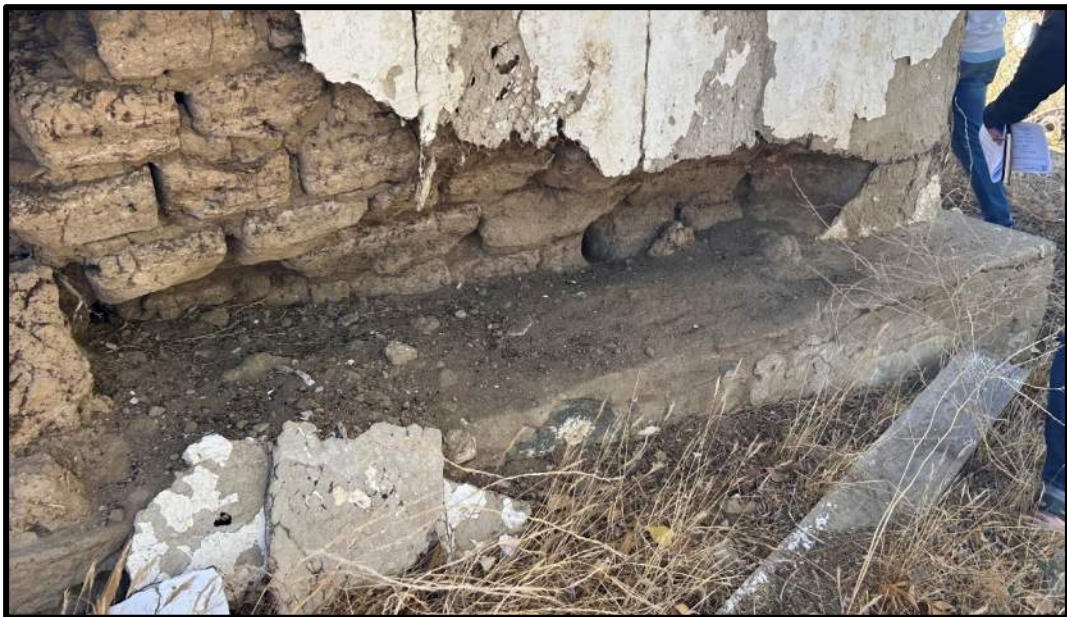
At portions of the adobe wall a past retrofit replaced the lower foot or so of the wall with concrete. Rising damp is when the adobe starts to wick up moisture from the soil, which can lead to accelerated deterioration at the base of the wall. This is likely why some portions of the lower wall were 'underpinned' in this manner as part of an earlier structural intervention.

Underpinning Replacing Lower Portion of Adobe Wall
