# PORT HUENEME QUARTERS D CONDITIONS ASSESSMENT REPORT

prepared by:  
**Heritage Architecture & Planning**  
633 Fifth Avenue  
San Diego, CA 92101

April 11, 2019

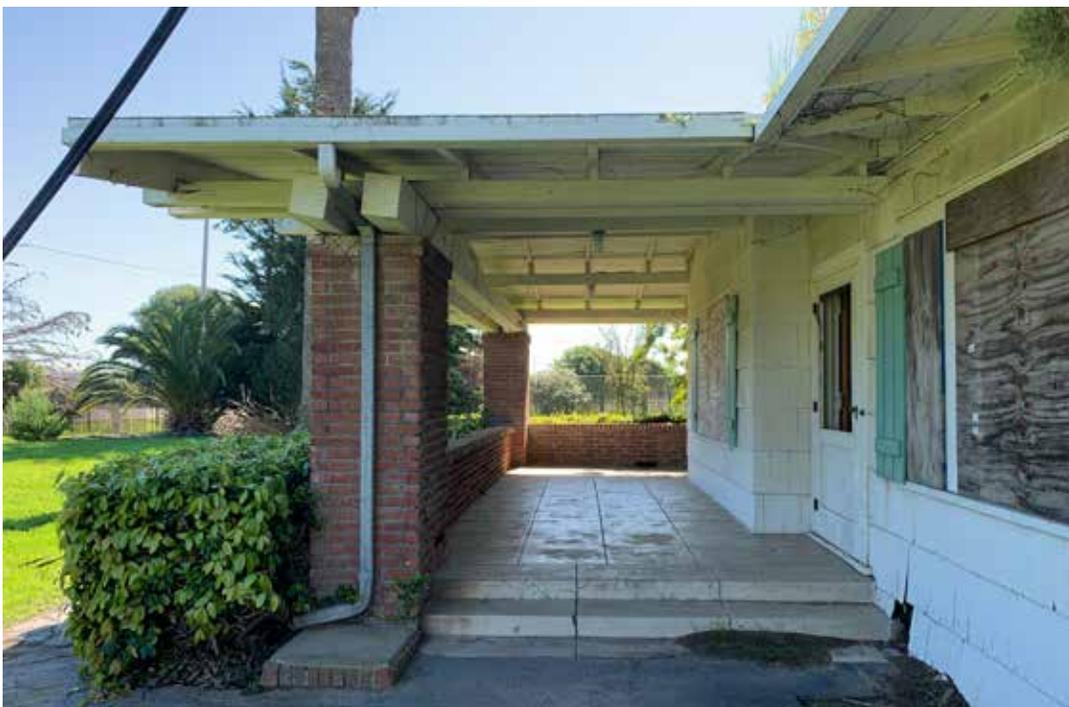
The front porch is a prominent architectural element. It features a low-sloped front gable roof supported on wide brick columns with a heavy exposed beam roof structure (refer to Photos 1, 7, 8, and 9). The porch has a scored concrete floor. Some minor damage was noted on the existing brick

columns. Additional structural beam deterioration is noted in the structural assessment. Paint finishes are generally deteriorated.

Photo 7: The front porch looking south. Note the two beams supporting the roof have twisted.

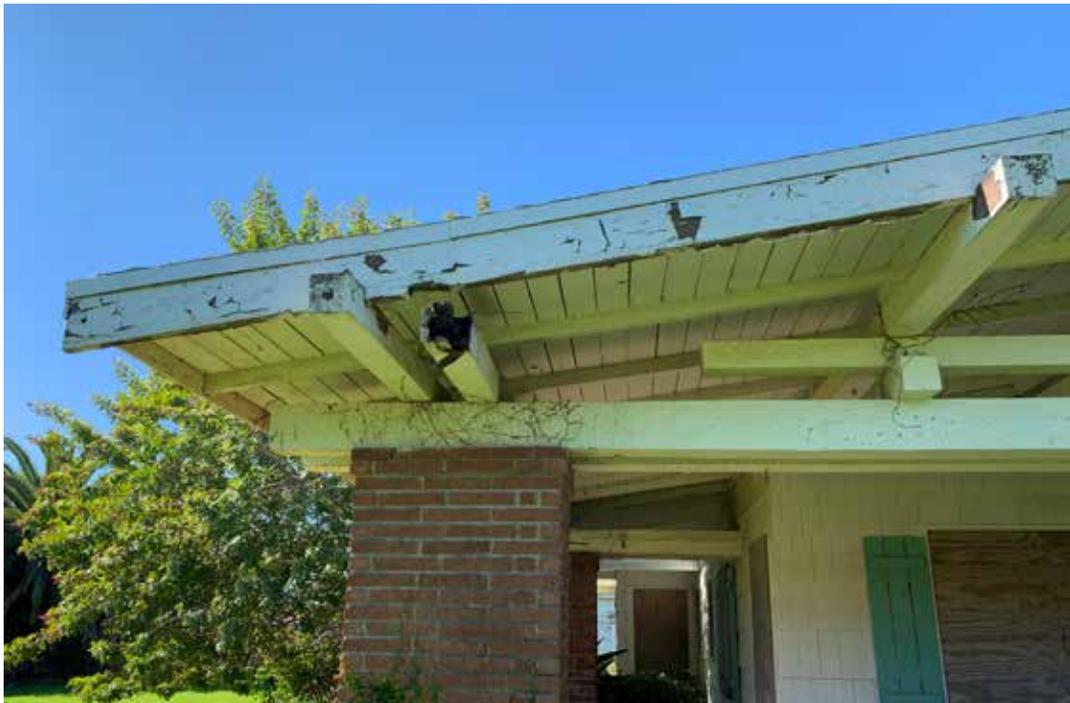
Photo 8: A damaged wood beam at the southeast corner of the porch.

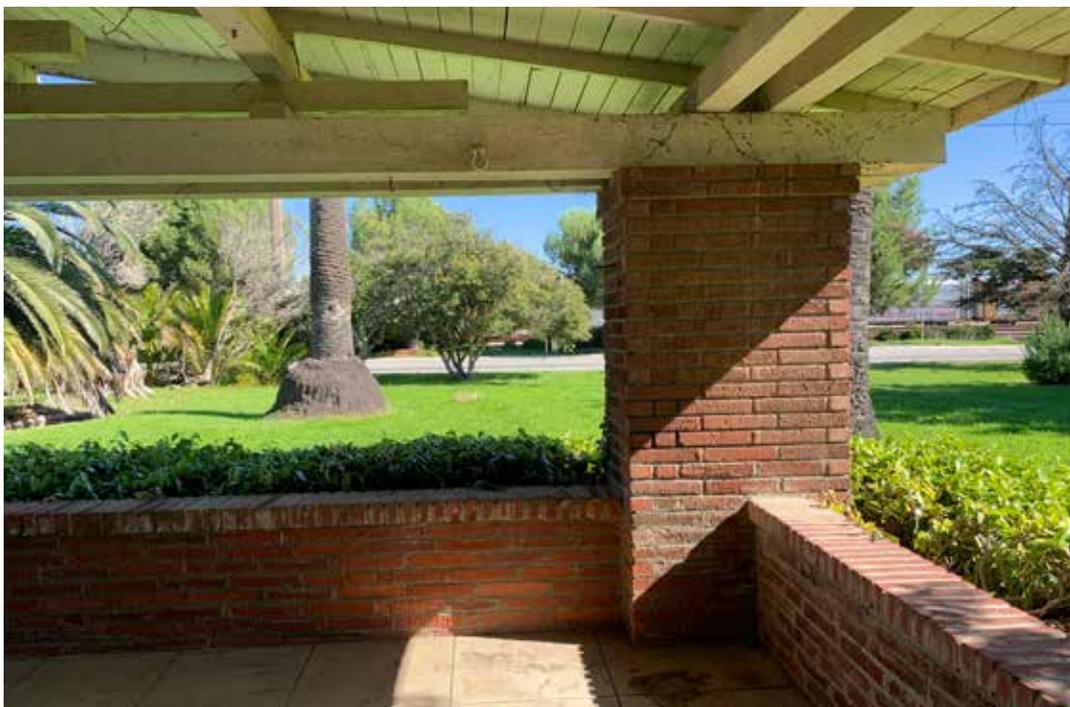
Photo 9: Brick columns and low walls at the porch.

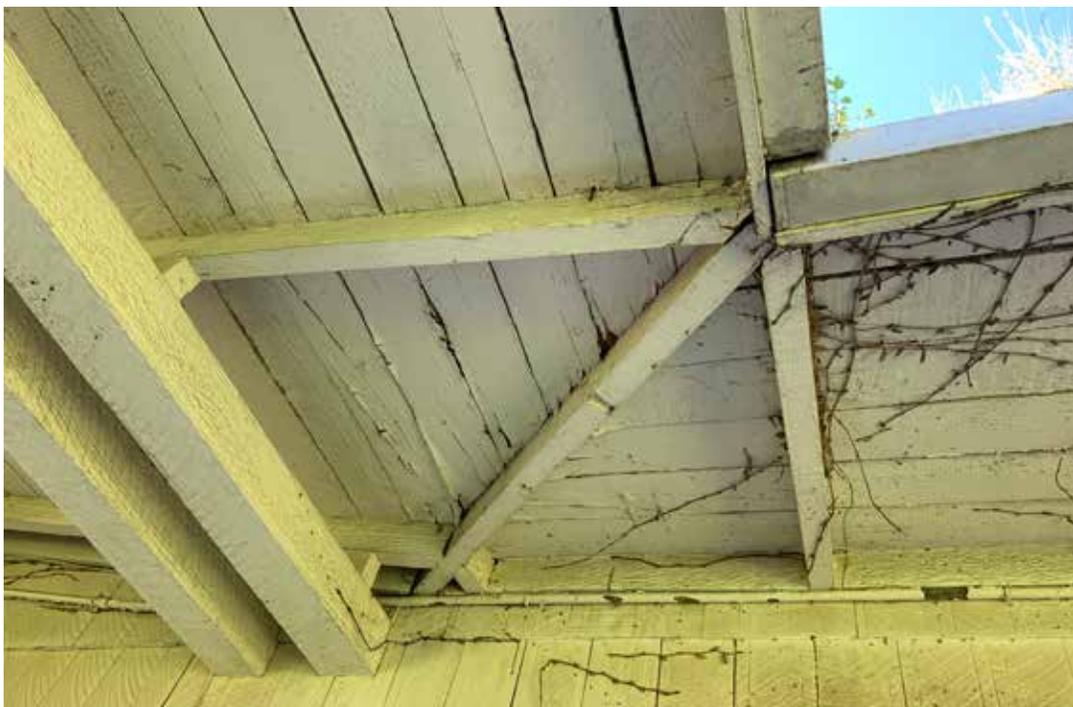
Photo 11: Typical wood and paint deterioration at the roof.

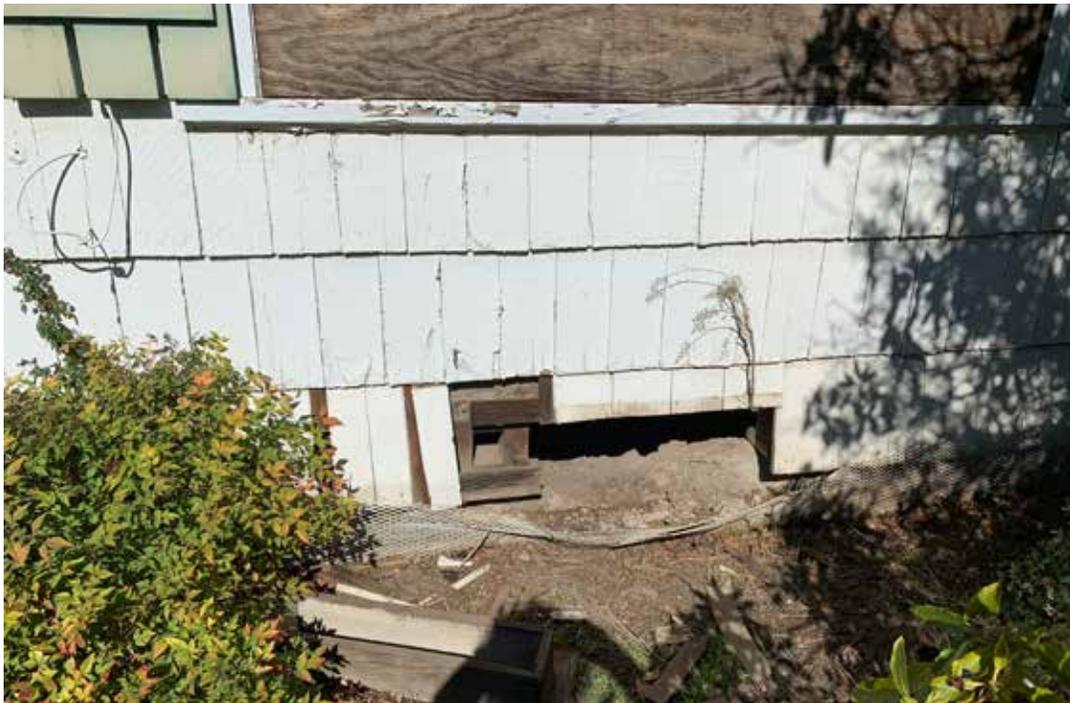
Photo 12: Missing shingles below the south window of bedroom 1. The original foundation vent screen and adjacent shingles are missing.

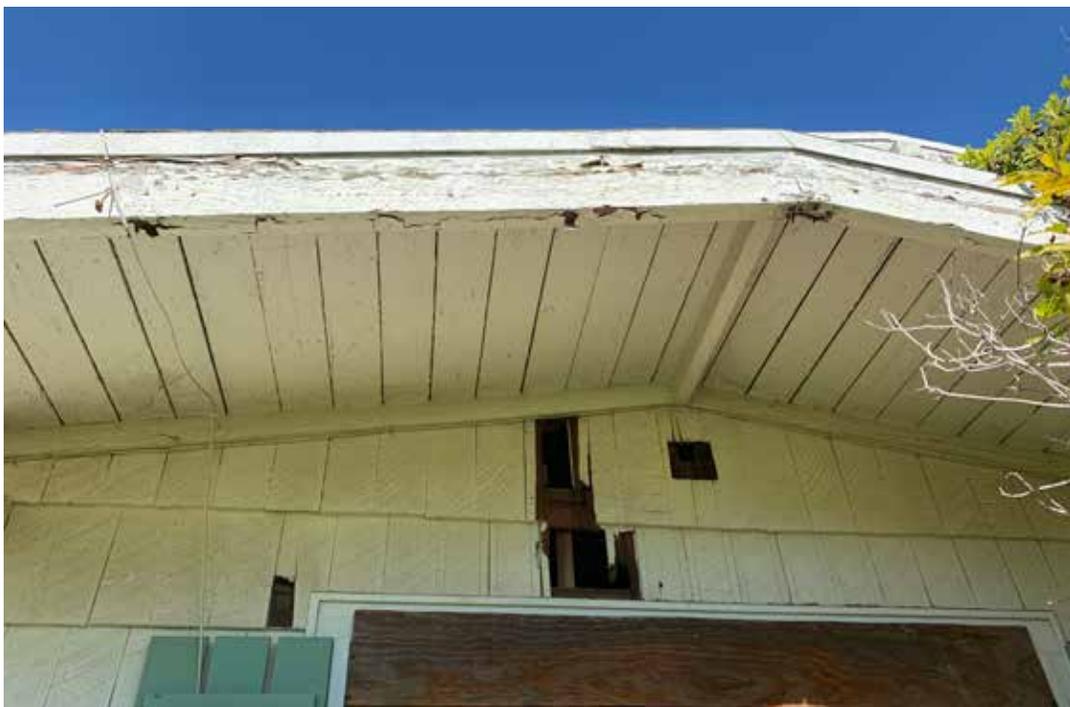
Photo 13: Missing shingles on the upper wall above the south window of bedroom 1.

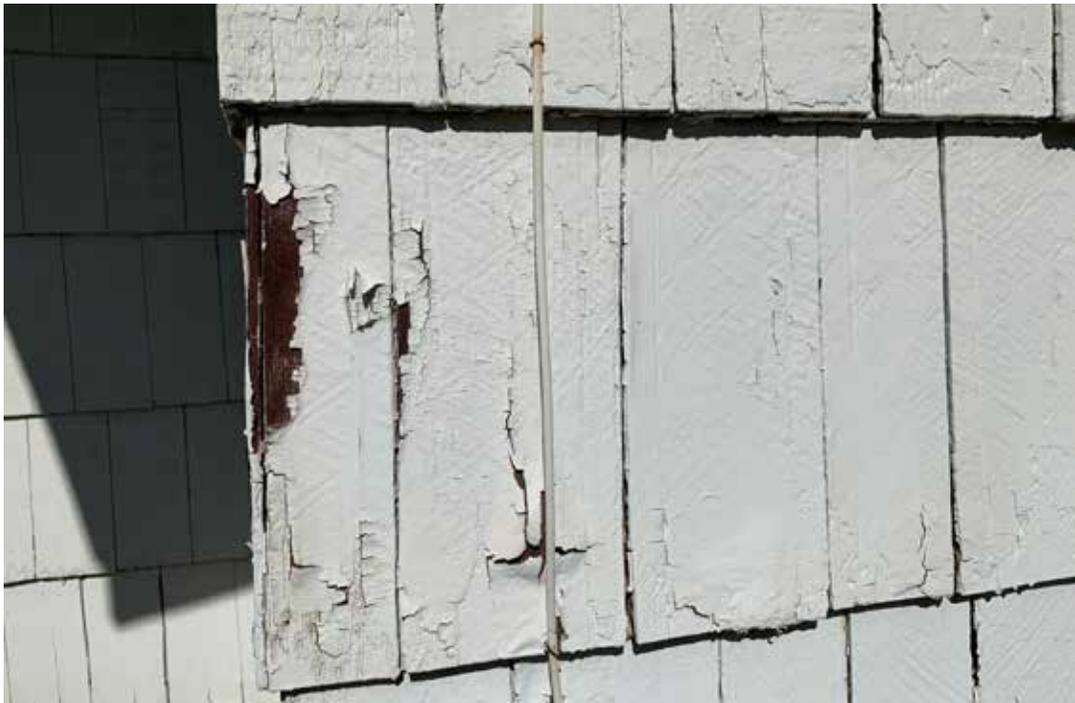
Photo 14: Typical paint deterioration on exterior wood shingles. The original dark brown stain color is visible below multiple layers of white paint.

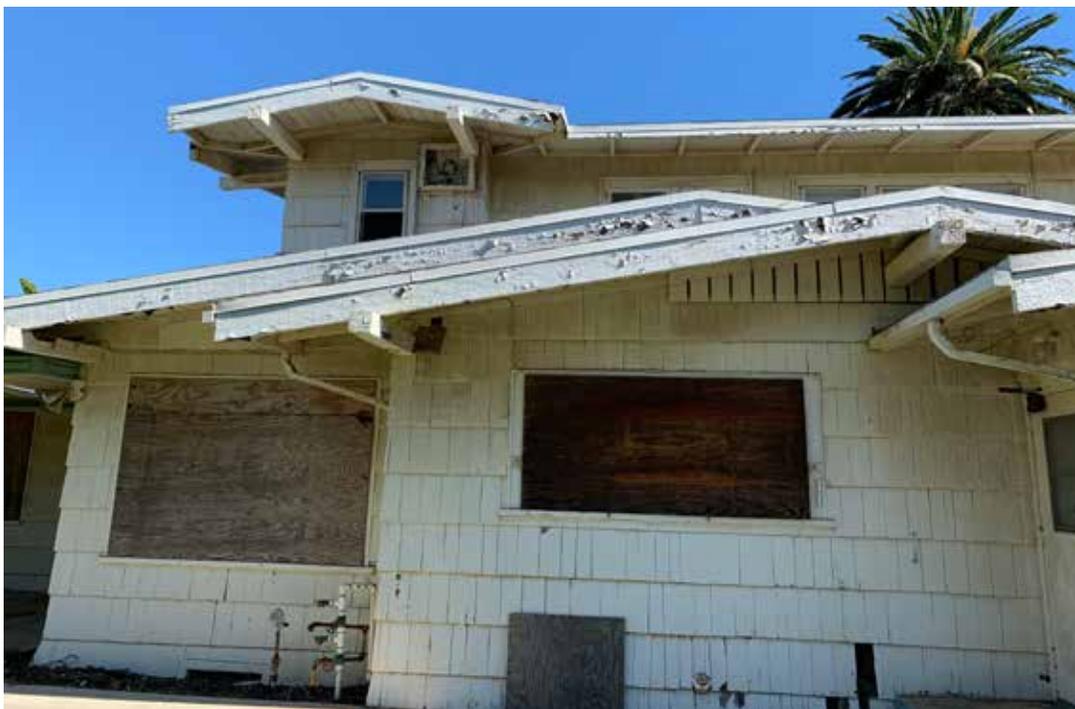
Photo 15: Typical paint deterioration on the west elevation.

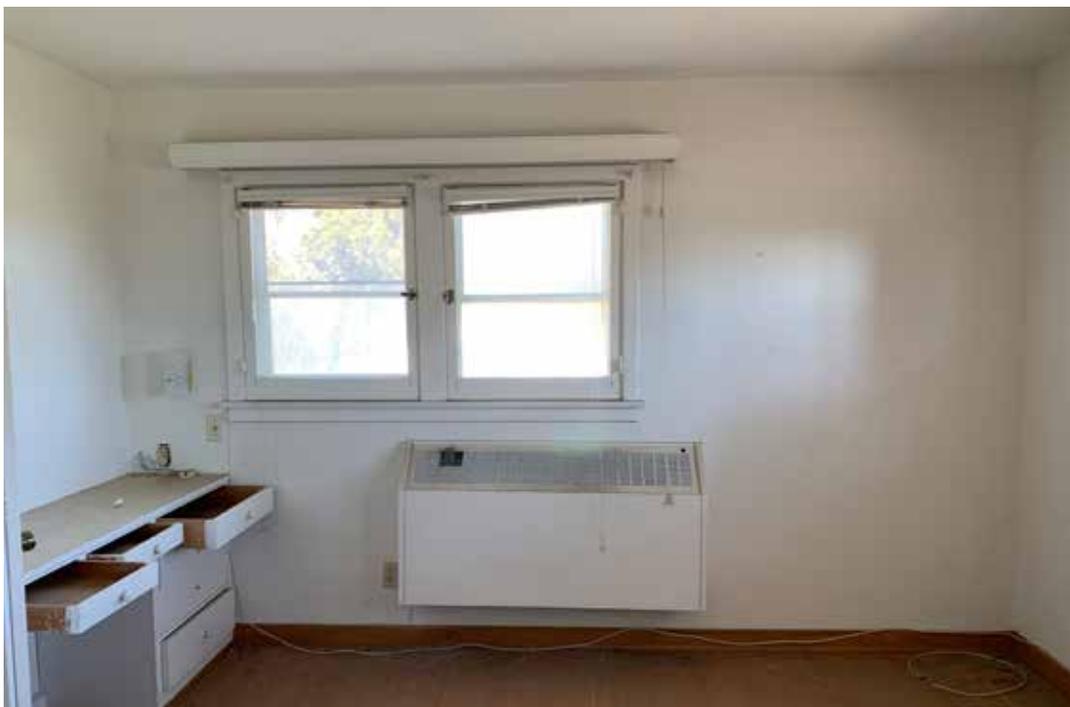
Photo 19: A pair of Type D (casement) windows on the north wall of bedroom 3. Note the non-historic aluminum window inserts that have been added on the exterior side of the windows.

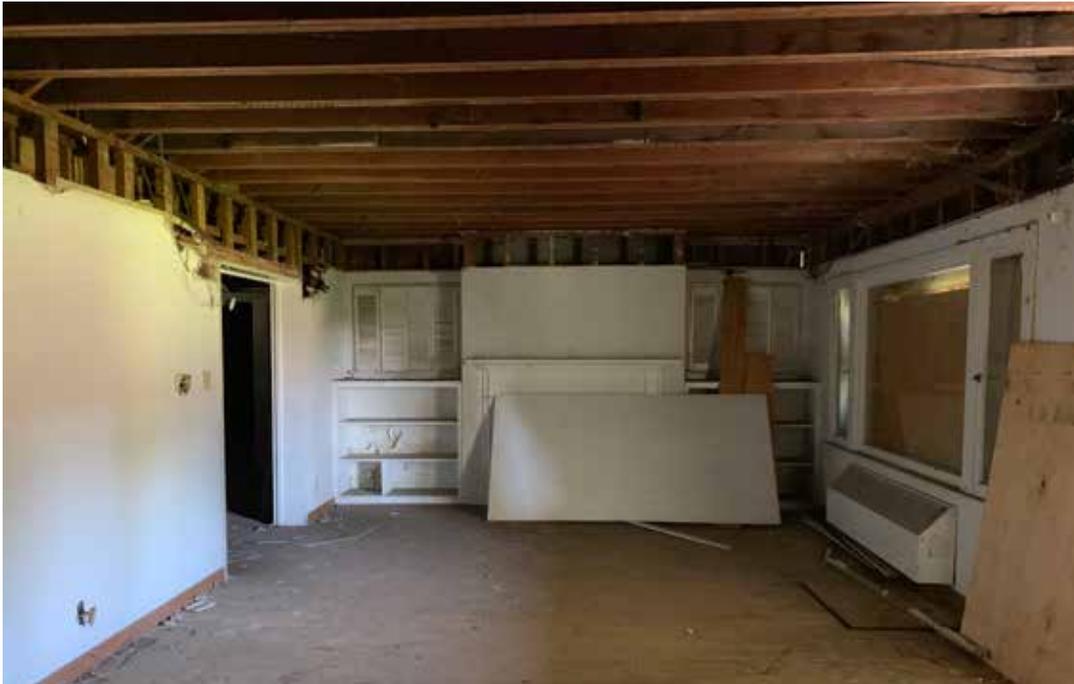
Photo 22: The living room looking north toward the fireplace. Note the original wood floor and missing plaster on the upper walls and ceiling.

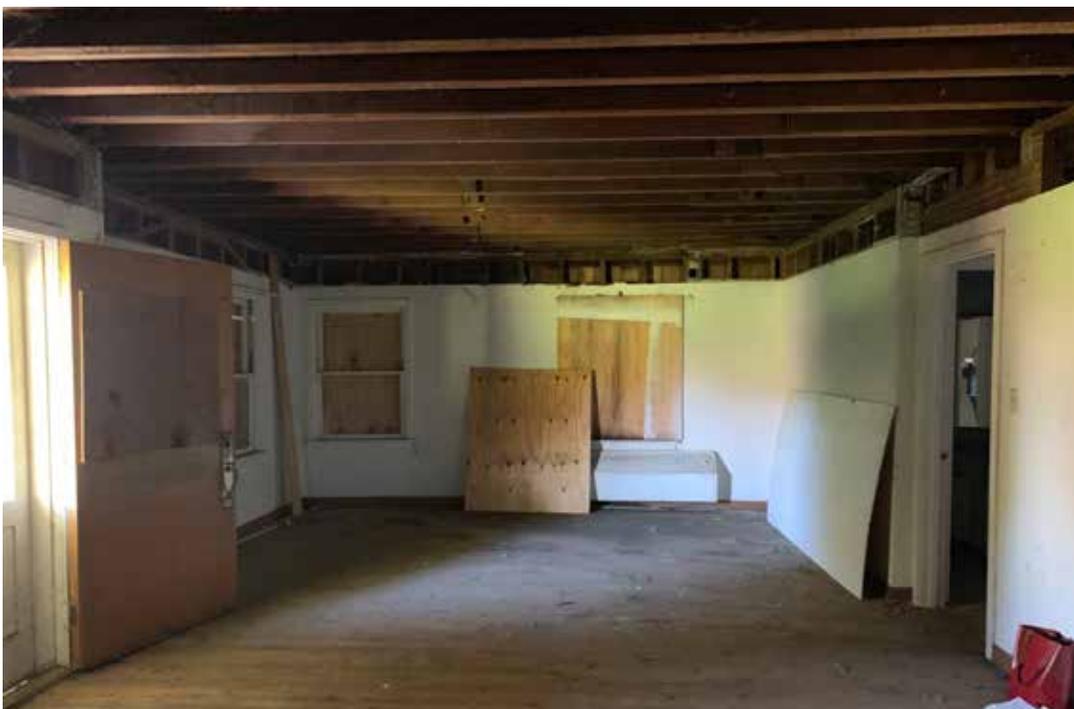
Photo 23: The living room looking south. Note the original wood floor and missing plaster on the upper walls and ceiling.

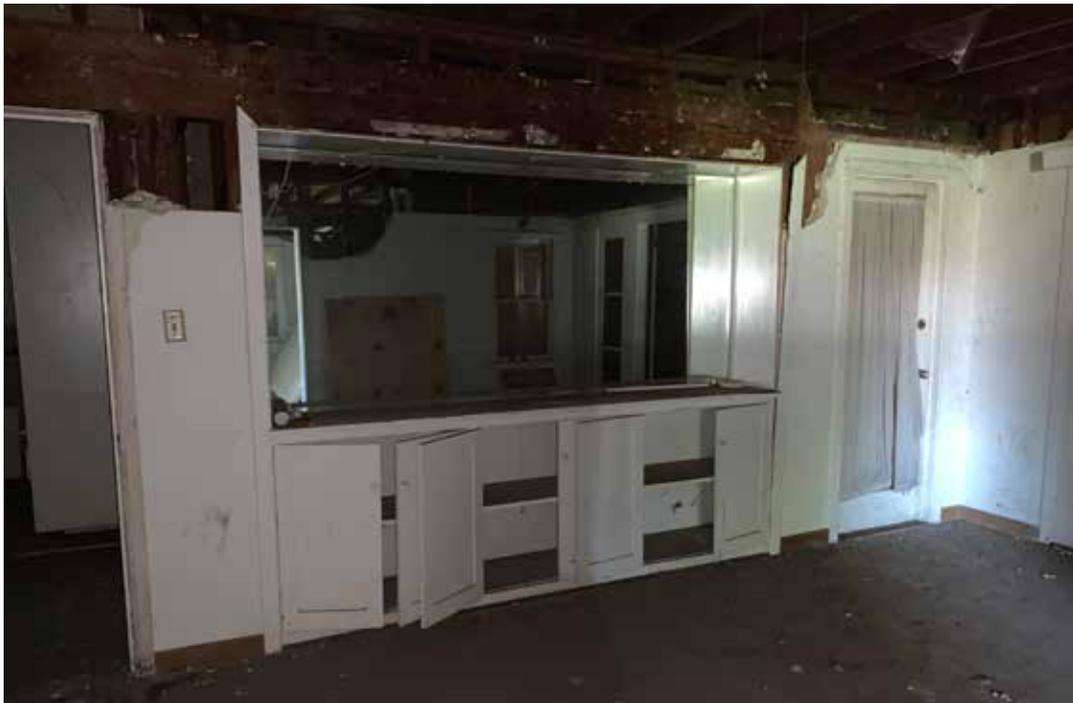
Photo 24: The dining room looking west at the modified original built-in buffet. Original wood flooring remains but plaster is missing from the upper walls and ceiling.

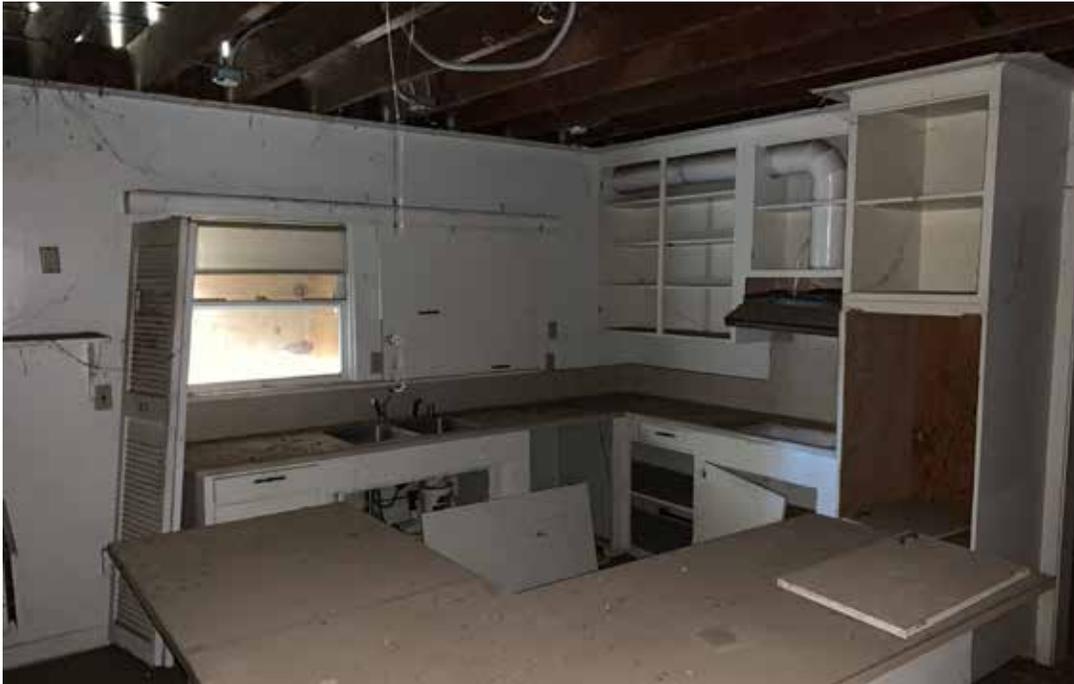
Photo 26: The kitchen looking northwest at modified/non-historic kitchen cabinets and counter tops. Cabinet doors and appliances have been removed.

- Remove and replace existing cabinetry and countertops. Assume custom grade wood cabinets with recessed panel doors, paint finish and solid surface countertops.
- Remove and replace existing sink.
- Install new appliances (premium grade stainless steel).

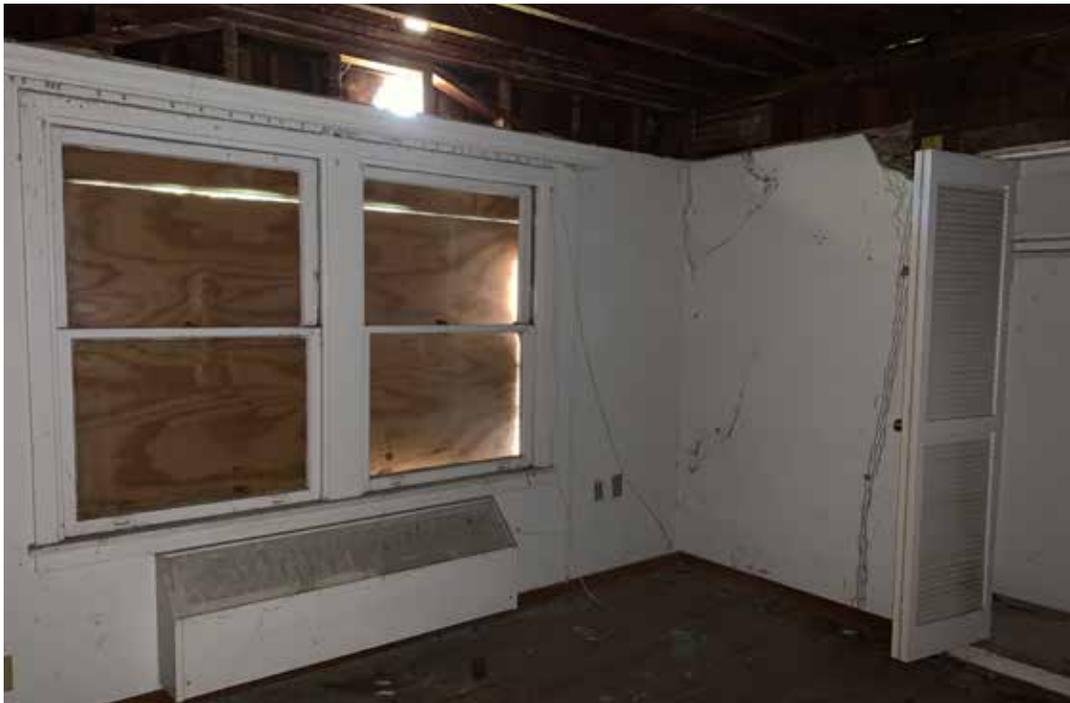
Photo 32: Bedroom 1 looking southwest. Plaster has been removed from the upper walls and ceiling. Original wood floors remain. Daylight is visible through the wall due to missing exterior shingles and interior plaster.

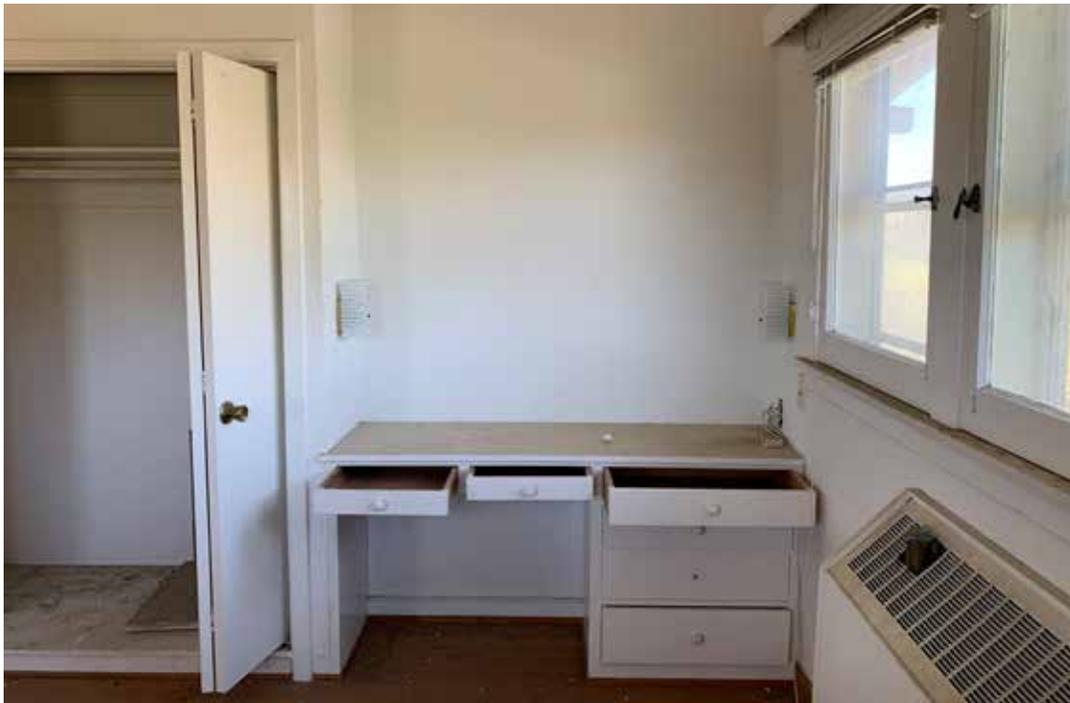
Photo 36: A non-historic built-in desk on the west wall of bedroom 3. The bi-fold closet doors are also non-historic.

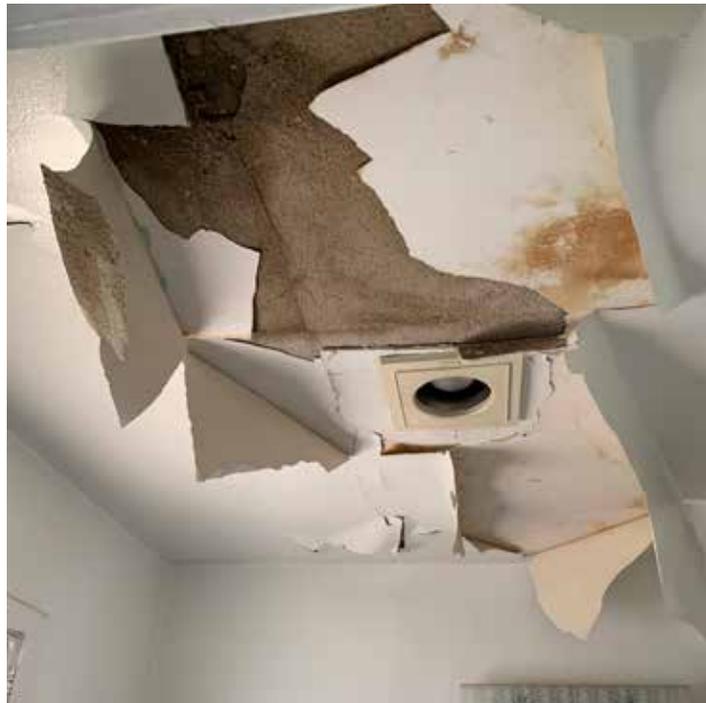
Approx. Rm. Size: 6'-7" x 5'-7"  
Floor Finish: Non-historic VCT  
Wall Finish: Plaster  
Ceiling Finish: Plaster, damaged (refer to Photo 38)  
Lighting: One non-historic ceiling-mounted light fixture/fan.

Photo 38: Damaged plaster ceiling and non-historic light fixture in bathroom 3.

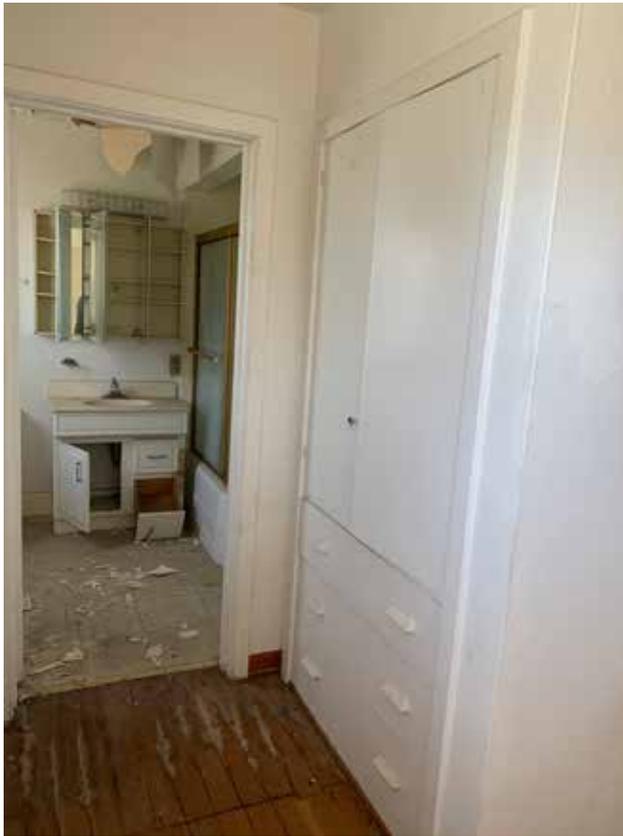
Photo 40: Original built-in linen cabinet in the upstairs hall. Note the water damage on the original wood floor in front of the bathroom door.

- Sand and refinish existing historic wood flooring in the living room, dining room, study, halls, and three bedrooms. Repair water damage in front of door to bathroom 3.

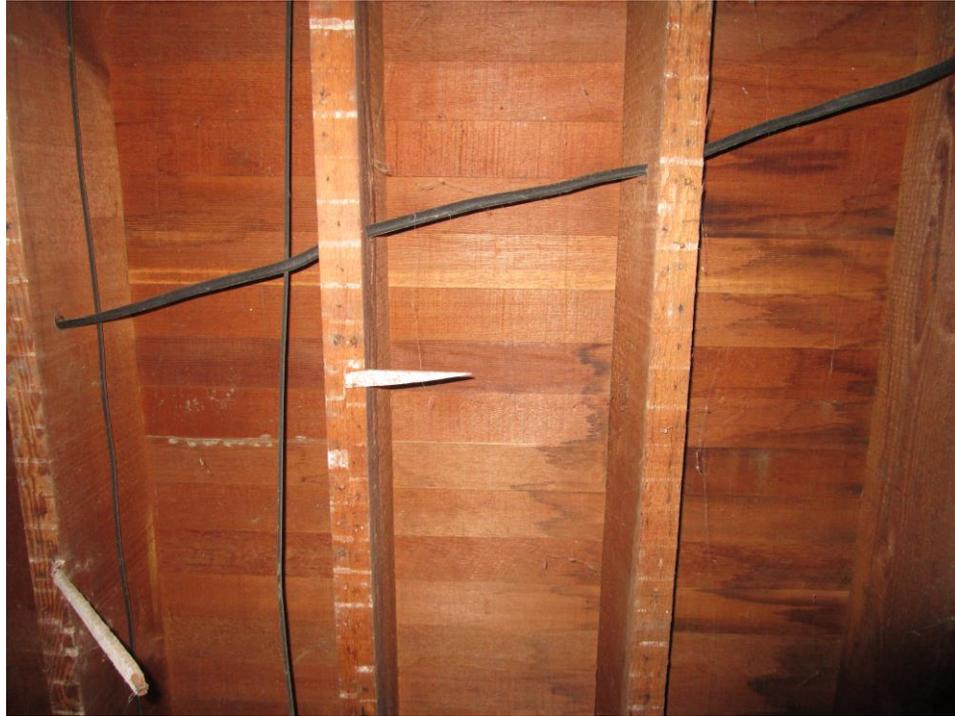
Floor framing appears in good condition and no signs of deterioration were noted in the observed areas. Water staining was observed in some locations (Photo 13).

**Photo 13 – Water staining in 2<sup>nd</sup> floor sheathing**

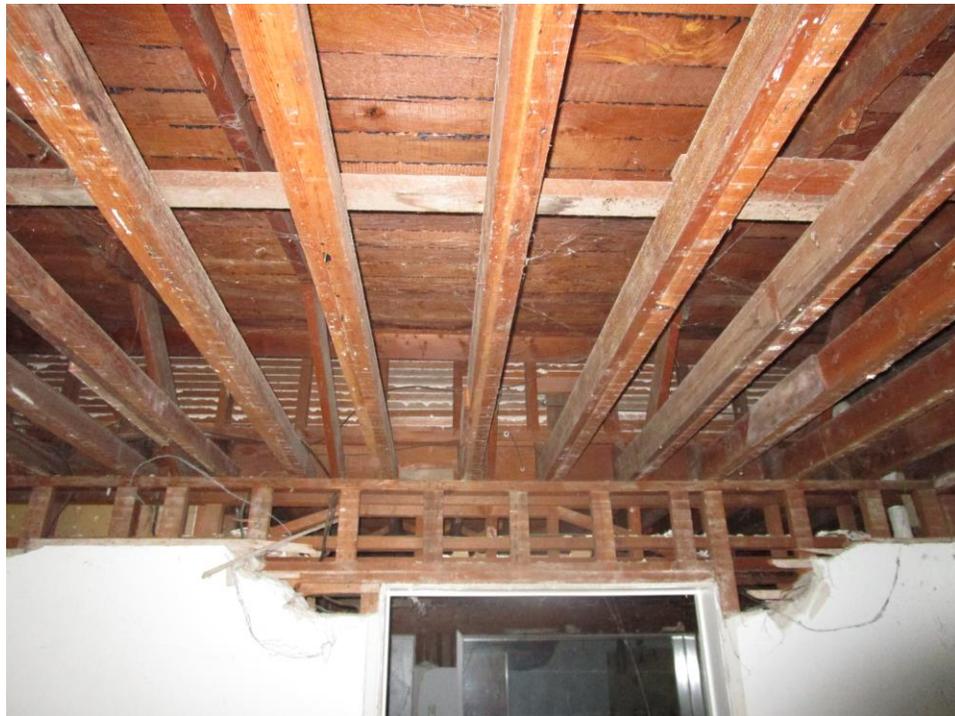
**Photo 14 – View of discontinuous lath and plaster**

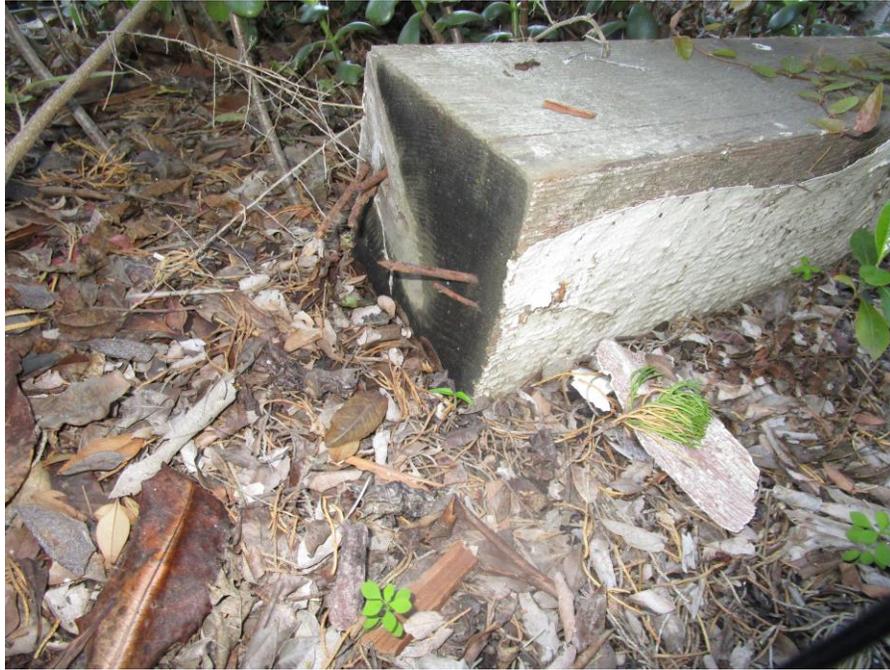
**Photo 17 – Failed faux beam connection**

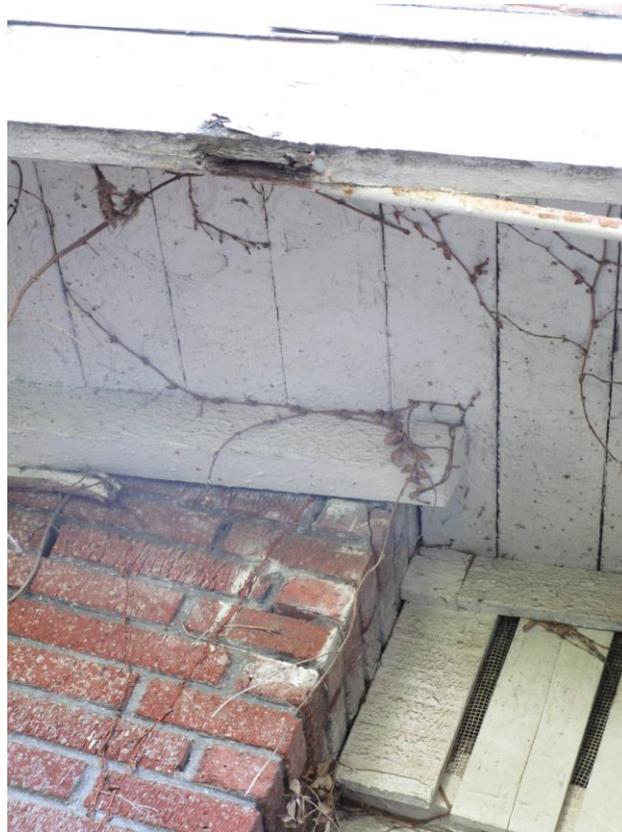
**Photo 18 – Original location of failed faux beam**

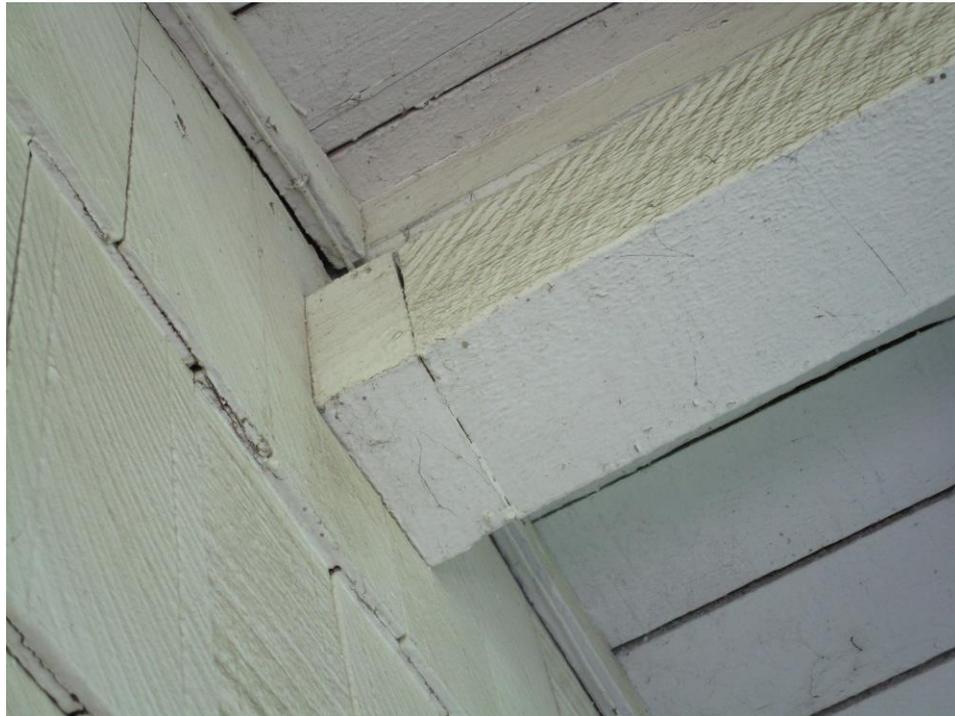
**Photo 19 – Susceptible toe nail connection of faux beam**

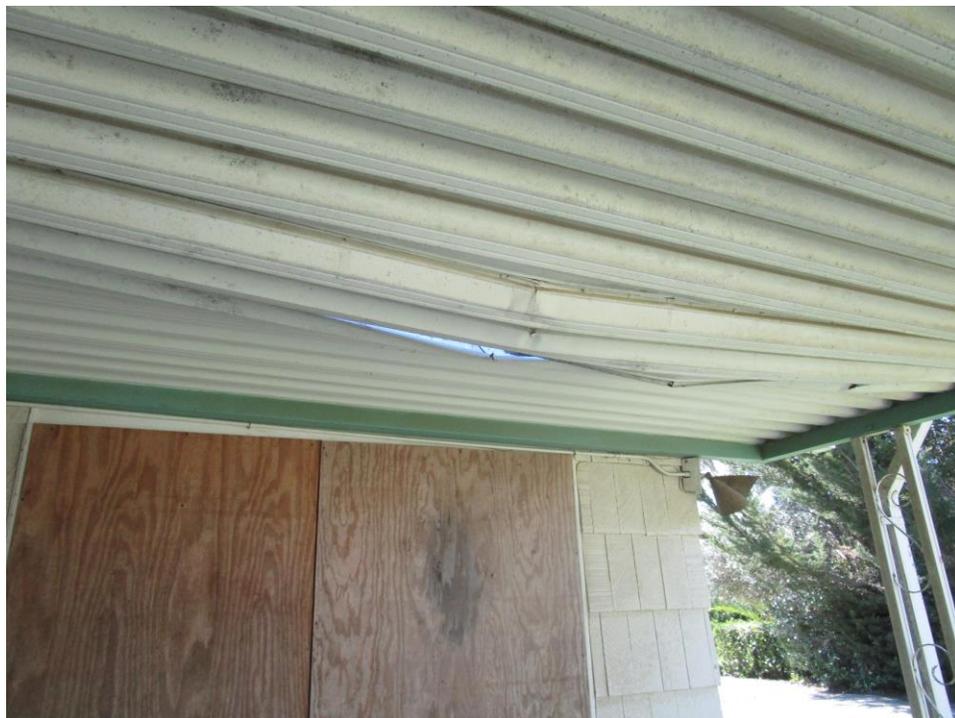
The exterior patio cover was observed to have sustained some impact (Photo 20).

**Photo 20 – Impacted patio cover roof**

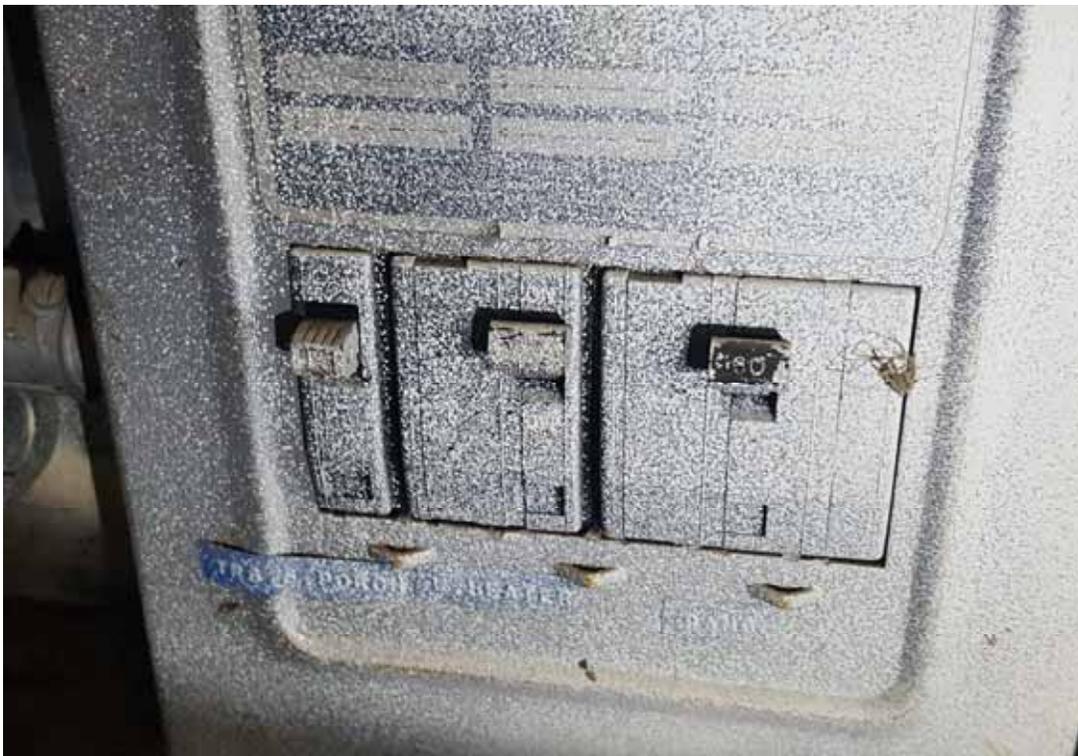
Porch lighting, water heater and range/oven circuit breakers in load center with paint.

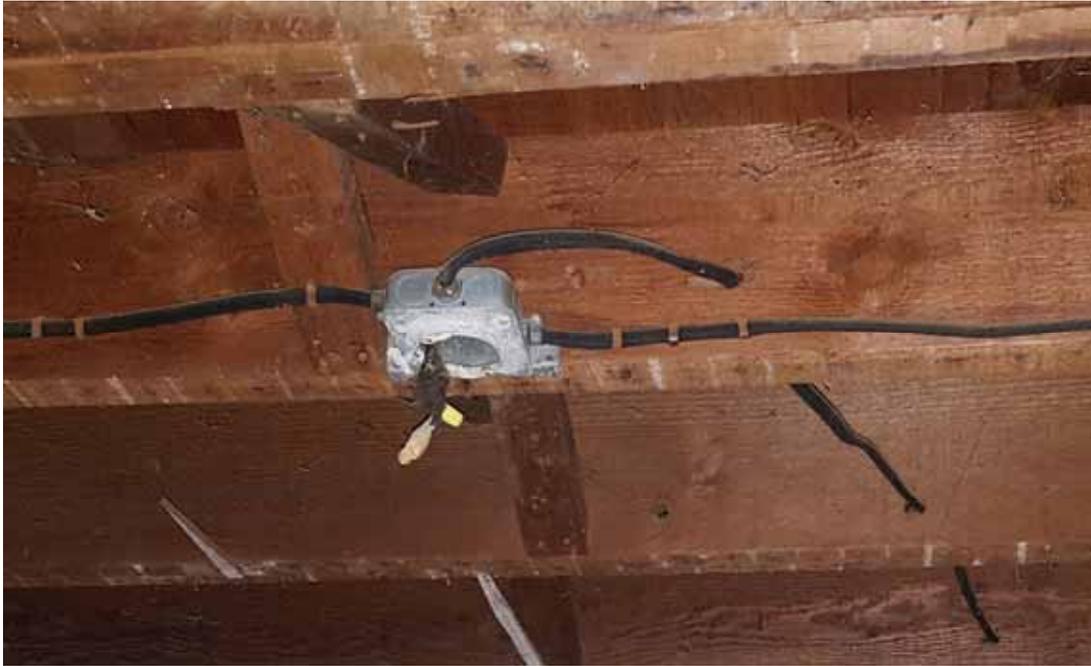
Conductors with cloth insulation at ceiling junction box.
