DOWNTOWN OXNARD HISTORIC RESOURCES SURVEY

FINAL REPORT JULY 2005

City of Oxnard 305 W. Third Street Oxnard, CA 93030

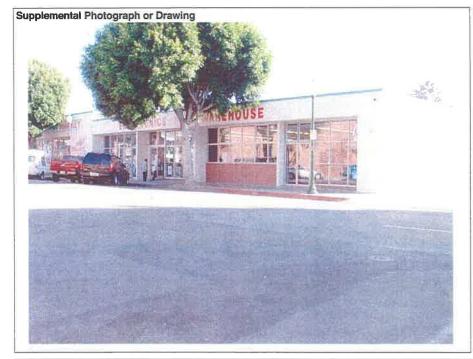
Description of Photo: (View, date, accession #) 210-18 W. Sixth St. (601 S. A St.) (View toward southeast). Photo No: 109-9, 11/12/2004

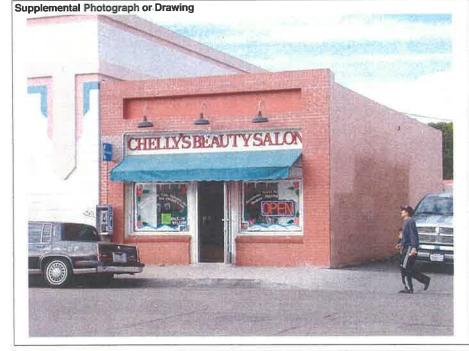
The original owner and builder of this property is unknown. It was built circa 1928 and occupied by Matilda Dominguez who ran a restaurant. By 1930, T. Kuniharo operated the restaurant.

While this property is of sufficient age to be considered potentially eligible for the NRHP and CRHR, retains its design integrity, and is generally associated with the commercial and residential development of Downtown Oxnard, it does not appear to be related to, or representative of this theme to any notable extent. This property is a minimal example of a common architectural style, and is not associated with any significant individual in Oxnard's history. Therefore, this property does not currently appear to be potentially eligible for individual listing in the NRHP or CRHR, as a City Landmark, or as a contributor to the formation of local, NRHP or CRHR-eligible historic district.

Description of Photo: (View, date, accession #)
129 W. Seventh St. (View toward
northwest). Photo No: 110-10, 11/30/2004

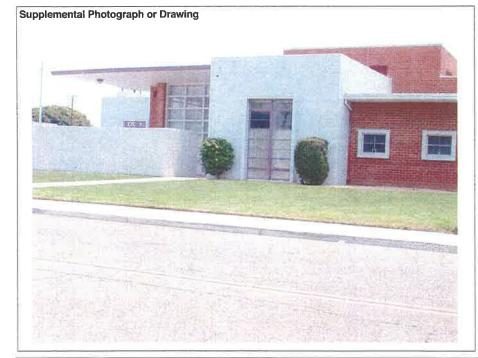
In 1949 the club hired Los Angeles architectural firm of Albert C. Martin to design their new building, which was completed in 1950. This prestigious firm was founded by A.C. Martin in the early 1900s in Los Angeles. Among his significant Ventura County commissions are the Ventura County Court House, St. Mary Magdelan Church in Camarillo and several Oxnard-area ranch houses. The firm remains in operation today, run by descendants of A.C. Martin.

Description of Photo: (View, date, accession #) 801 S. A St (View toward south). Photo No: 126-5, 7/20/2005

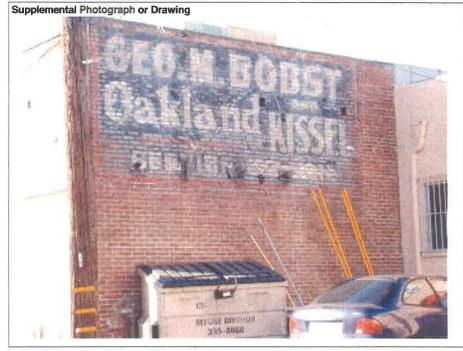
Rear of 102 E Fifth Street

Description of Photo: (View, date, accession #) 100 E. Fifth St. (rear) (View toward northwest). Photo No: 113-46, 1/20/2005

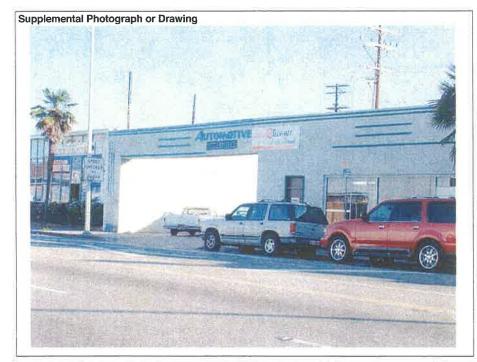
This commercial property is Modern in design. It is composed of two building, linked only by a small portion of common wall. The building located at 214 E. Fifth, constructed circa 1948, is a one story building with a flat roof. The building is two bays wide. The right bay is filled with a large metal-frame storefront window with multiple plate glass panes. A single entrance door is located to the left of the storefront window. A large, double-wide opening is located in the left bay, provided access to the rear of an auto body shop. The edges of the walls, the parapet wall, and the top of the parapet are decorated by raised stringcourses, arranged in pairs or groups of three. Along the upper wall, the stringcourses are broken for decorative effect. The condition of the building is fair.

Description of Photo: (View, date, accession #)
214 E. Fifth St. (View toward southeast).
Photo No: 113-41, 1/20/2005

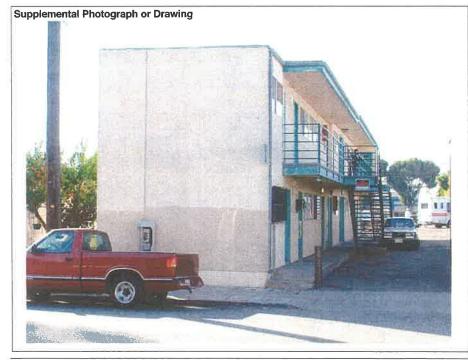
This residential building, in use as either an apartment or motel, is vernacular in design with modernist elements. With a rectangular plan, the building is two stories tall with a flat roof. Exterior walls are clad with stucco. The street elevation is a solid wall, unbroken by fenestration. The building is oriented to its asphalt driveway and parking area; the main façade is on this side of the building. Two open-tread stairwells provide access to the second floor. A cantilevered balcony, with a flat canopy and a metal balustrade with horizontal rails, extends the length of the second floor. A series of single entrance doors and windows are located along both the first and second floor. Windows are single-pane, aluminum frame sliders. The condition of the building is fair.

This hotel building was constructed by owner L.M. Franco in 1966 by K.Y. Construction.

Description of Photo: (View, date, accession #)
635 Meta St. (View toward southwest).
Photo No: 113-15, 1/20/2005

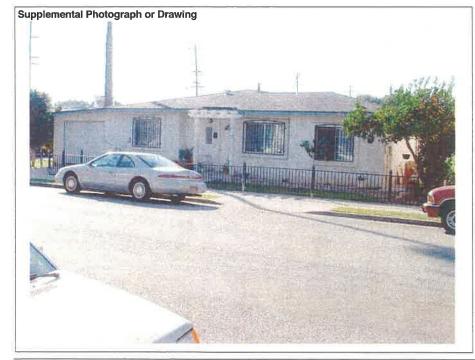
645 Meta St

This single family stucco clad residence features a low-pitched hipped roof and aluminum sliding windows, and was constructed in 1960.

Description of Photo: (View, date, accession #)
645 Meta St. (View toward west). Photo No:
113-14, 1/20/2005

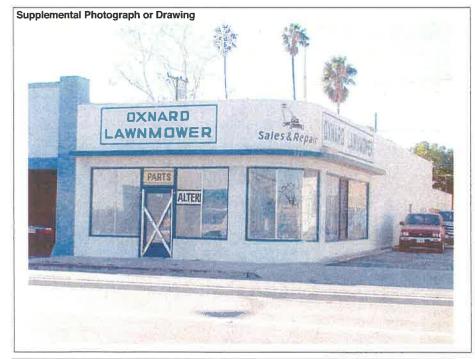
The one story commercial building located at 221 S. Oxnard Blvd. is vernacular in design. The building is rectangular in plan and has a flat roof behind a parapet. The building's main architectural features is a band of storefront windows wrapping around the eastern and northern elevations above a low bulkhead and topped by shallow projecting eaves. The corner of the building is curved, mildly suggesting the Streamline Moderne style. A storefront door is located midway on the eastern elevation. The condition and integrity of the building are good.

Description of Photo: (View, date, accession #)
221 S. Oxnard Blvd. (View toward southwest). Photo No: 111-5, 12/17/2004

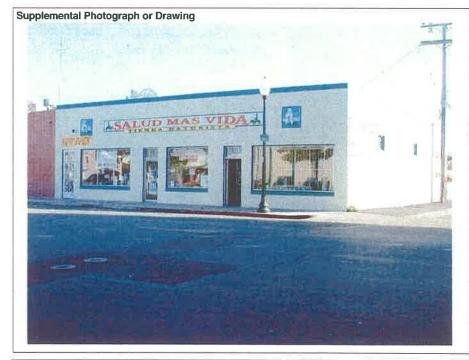
The building at 112-116 (120) W. Sixth St. is rectangular in plan, one story tall, and topped by a flat roof with a short parapet wall. Exterior walls appear to be clad with stucco. Three simple storefronts of varying widths are located on the main façade. Each storefront has a simple plate glass window and an adjacent single entrance door with transom. Fenestration on the secondary façade is limited to two small square windows.

This building was built in 1945 for J. Jimenez as a pool hall and tamale factory and appears to be relatively unaltered. The building (120) was altered on the interior for a laundromat in 1957 by Krouser Enterprises.

Description of Photo: (View, date, accession #) 112-120 W. Sixth St. (601-13 Oxnard Blvd.) (View toward southeast). Photo No: 109-8, 11/12/2004

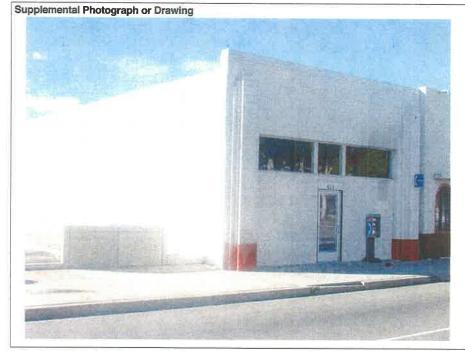
611 S. Oxnard Blvd. is a commercial storefront. The building has a rectangular plan, is one story tall, and one bay wide. The flat roof is concealed by a short parapet. The ground-level storefront has a central entrance and a three-part transom. The storefront windows have been enclosed and covered with a stucco coating. Two pilasters with a stepped capital frame the storefront. Both the pilasters and the upper wall of the storefront are scored to create the appearance of large stone blocks. The secondary façade has a series of simple pilasters but is otherwise unadorned.

This building was constructed circa 1945 and was occupied by a restaurant in 1950. The storefront has been significantly altered.

Description of Photo: (View, date, accession #) 611 S. Oxnard Blvd. (View toward northwest). Photo No: 112-30, 1/4/2005

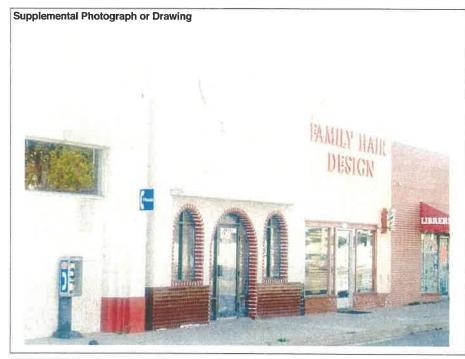
609 S. Oxnard Blvd. is a two-part commercial storefront. The one story building has a rectangular plan and a flat roof with a short parapet. The exterior walls are clad with stucco that does not appear original. The right storefront is a simple central entrance door with flanking plate glass windows above a brick bulkhead. Business signage is the only ornament on the wall above. The left storefront has an arcaded central entrance and two arched windows. Both the doorway and windows are lined with brick. The bulkhead is covered with square tiles. A shallow canopy extends across the storefront; the wall above is otherwise unbroken.

This building was constructed circa 1945 and was substantially altered in 1976.

Description of Photo: (View, date, accession #)
609 S. Oxnard Blvd. (View toward
northwest). Photo No: 112-31, 1/4/2005

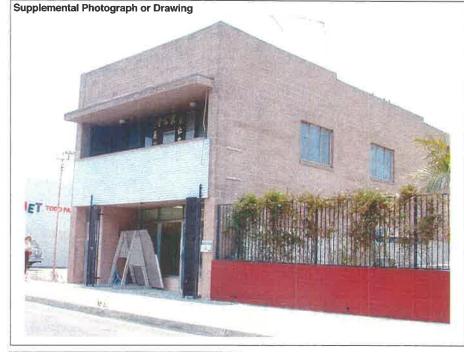
This property has been at the heart of Oxnard's Chinatown since the early 1900s. A row of one and two story wooden buildings along Saviers Road served as stores and residences for Chinese residents. China Alley was located between A Street and Saviers Road.

While this property is of sufficient age to be considered potentially eligible for the NRHP and CRHR, retains its design integrity, and is generally associated with the commercial and residential development of Downtown Oxnard, it does not appear to be related to, or representative of this theme to any notable extent. This property is a minimal example of a common architectural style, and is not associated with any significant individual in Oxnard's history. Therefore, this property does not currently appear to be potentially eligible for individual listing in the NRHP or CRHR, or as a contributor to the formation of local, NRHP or CRHR-eligible historic district. However, this property appears to qualify for designation as a City Landmark for the unique role it played in the social life of Oxnard's Chinese community.

Description of Photo: (View, date, accession #) 749-51 S. Oxnard Bl. (View toward southwest). Photo No: 126-4, 7/20/2005

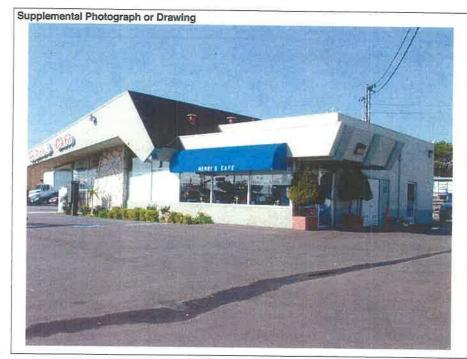
While this property is of sufficient age to be considered potentially eligible for the NRHP and CRHR, retains its design integrity, and is generally associated with the commercial and residential development of Downtown Oxnard, it does not appear to be related to, or representative of this theme to any notable extent. This property is a minimal example of a common architectural style, and is not associated with any significant individual in Oxnard's history. Therefore, this property does not currently appear to be potentially eligible for individual listing in the NRHP or CRHR, or as a contributor to the formation of local, NRHP or CRHR-eligible historic district.

However, this property appears to qualify for designation as a City Landmark as an essentially unaltered example of Googie coffee shop architecture designed by architects Armet and Davis.

Description of Photo: (View, date, accession #) 1060 S. Oxnard Blvd. (View toward northwest). Photo No: 113-6, 1/20/2005

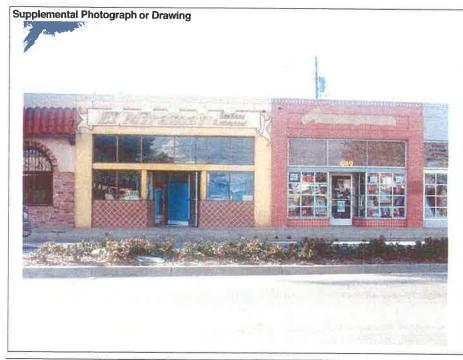
This building may have been constructed by K. Inadomi circa 1930 for use as part of his grocery store located at 115 W. Seventh St.

This property is generally associated with the commercial and residential development of Downtown Oxnard, but it lacks sufficient integrity of design, setting, workmanship and materials to be regarded as potentially eligible for individual listing in the NRHP or CRHR or for designation as a City Landmark, or as a contributor to the formation of local, NRHP or CRHR-eligible historic district.

Description of Photo: (View, date, accession #) 649-53 S. Oxnard Blvd. (View toward west). Photo No: 112-27, 1/4/2005

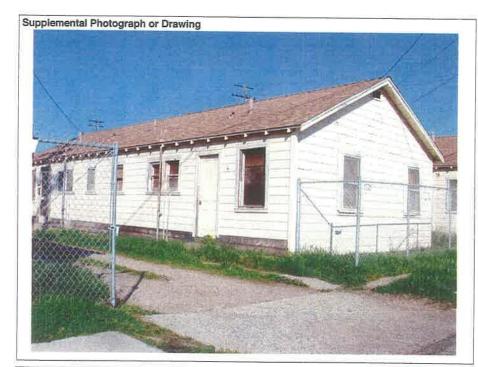
Description of Photo: (View, date, accession #)
225-31 E. Sixth St. (View toward
northeast). Photo No: 113-26, 1/20/2005
