**Re: Recommendations for Historic Preservation Compliance, Lockwood Valley Ranch,
Unincorporated Ventura County, California**

ATTACHMENT A: Photographs of Reyes Adobe

ATTACHMENT B: Structural Engineers Report

RE: Reyes Adobe
Silman Project No 3026.0030145

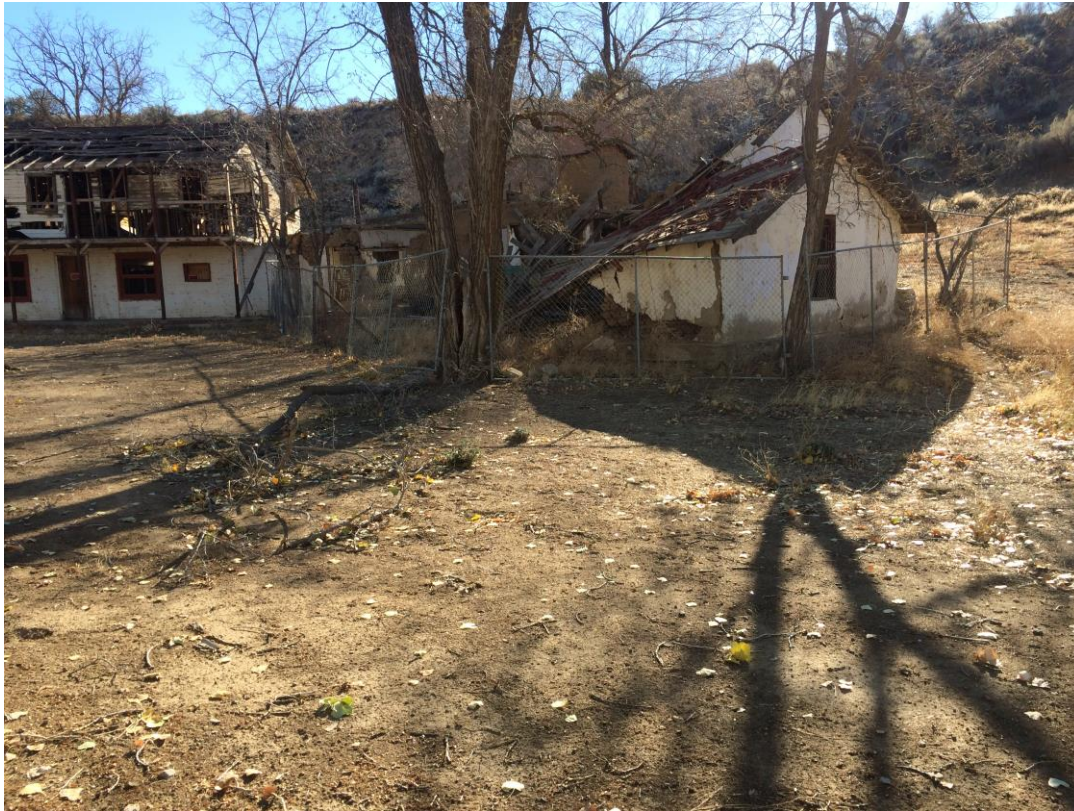
The Reyes Adobe is located in northern Ventura County on Lockwood Valley Road two miles east of Route 33. The main building consists of a two-room adobe constructed in 1854 with several alterations and additions made over the years, including a two-story addition on the south end (c. 1947) (Figure 8). Other buildings on the parcel include a smokehouse (1854) located approximately 15 feet west of the main building, a cabin (1956) (Figure 9) and a washroom (1947) (Figure 10).

Figure 8. Overview of adobe and addition looking southwest.

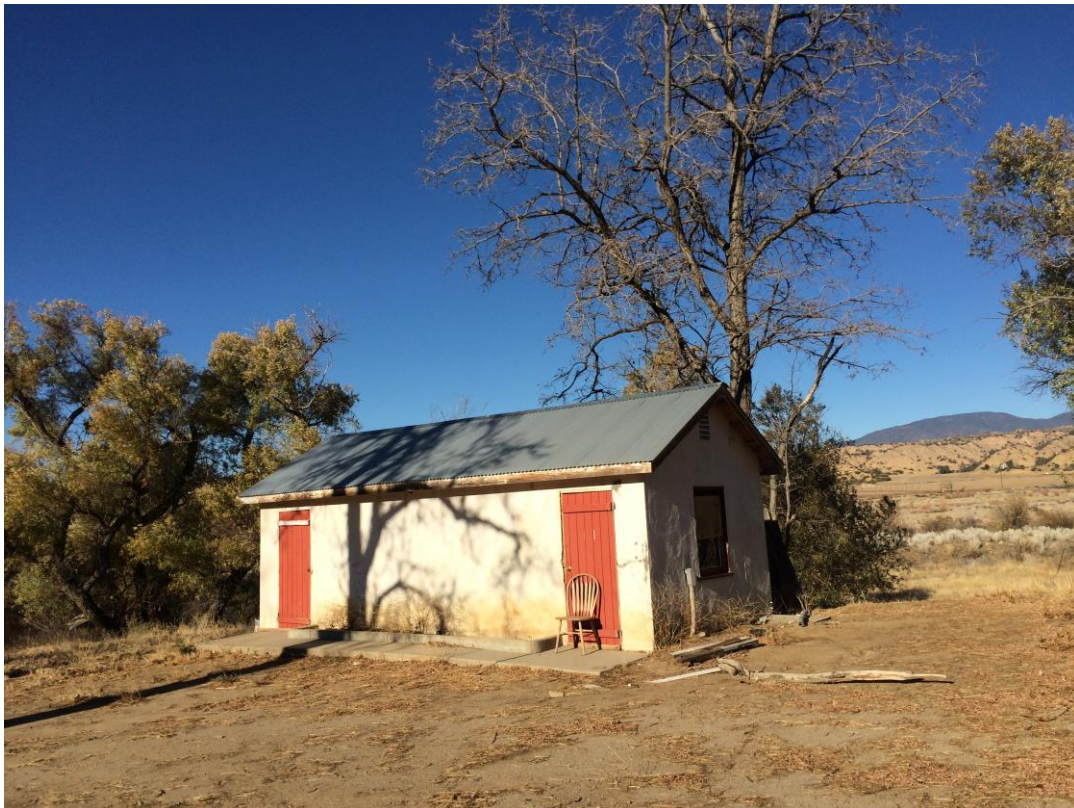
Figure 9. View of cabin on property built 1956, looking northwest.

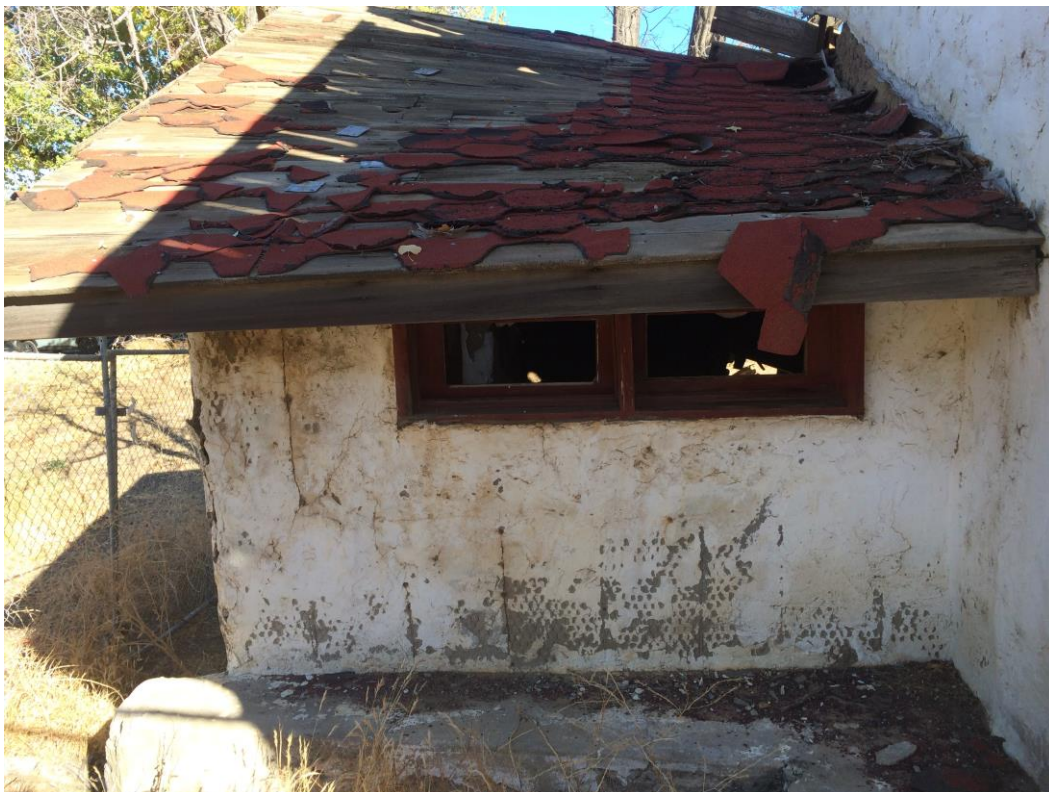
The adobe walls of the later additions to the north are still standing, indicating the original side gable shape of the roof (Figure 12). Portions of these walls have been covered with cement and have the only recognizable fenestration. A one-over-one sash window is located on the north façade and a clerestory window in the upper section of the west façade (Figure 13). Although the central portion of the adobe is mostly deteriorated, a chimney located in the middle of the original section is still extant (Figure 14). Because most of the walls have collapsed, it is difficult to determine the fenestration pattern in this central section. A door was located near the chimney on the east façade, with another on the south end near the two-story building. Historic photographs and assessor records indicate the building had a porch spanning the section from the north addition to the two-story building added in the 1940s (Figure 15).

Figure 13. Detail of clerestory window on west façade of addition.

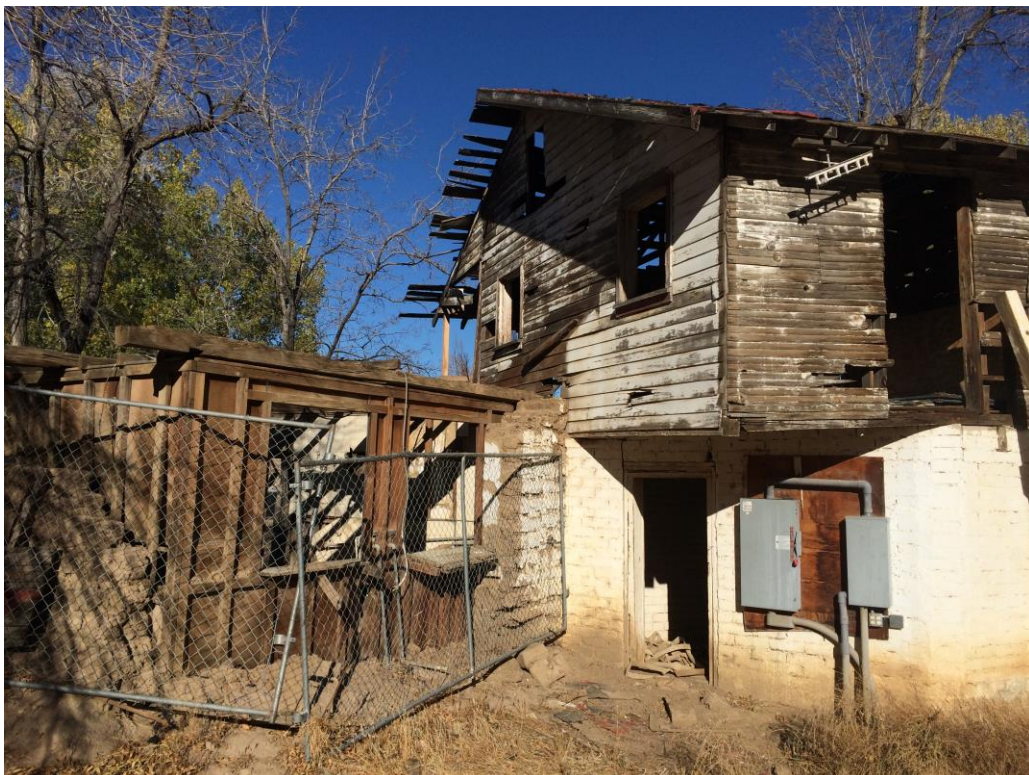
The south façade has a window matching those on the east façade at the east end of the first story, and a narrow window to the west which at one time contained glass block (Figure 17; see Figure 7). On the second story there were originally two square-shaped windows but only the openings remain. There was also a small window near the gable end. On the west façade, some openings have been covered with concrete, but there are still two openings on the north end of the first story (Figure 18). On the second story, the deteriorating clapboard makes the fenestration pattern unclear, but one frame is located near the south corner with two additional openings to the north. A portion of the second story overhangs the first at the northwest corner and there is a door located on the angled wall below near the junction with the one-story building. The second story of the north façade has two square openings with an additional window in the gable end (Figure 19).

Figure 19. Oblique view of south façade of two-story addition, view towards the northeast.
