# PORT HUENEME QUARTERS D CONDITIONS ASSESSMENT REPORT

prepared by:  
**Heritage Architecture & Planning**  
633 Fifth Avenue  
San Diego, CA 92101

April 11, 2019

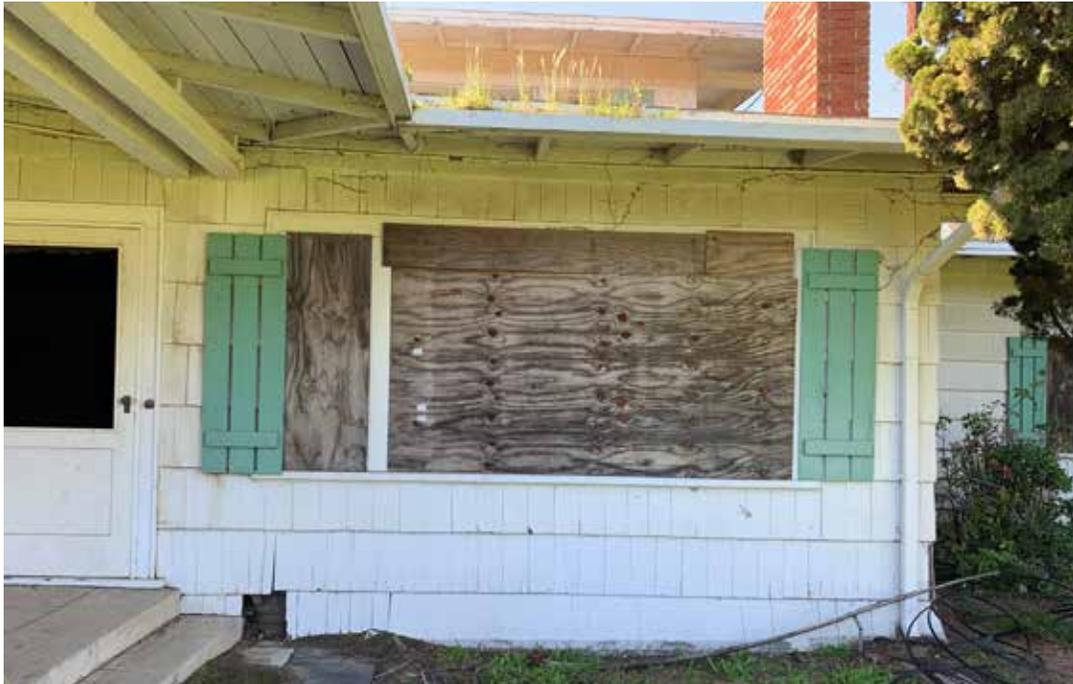
The exterior walls of Quarters D are clad with original wood shingles (refer to Photo 10). The shingles are 16” long and approximately 6” wide. They are installed with a typical exposure of 14”. The shingles are currently painted white. The paint finish is deteriorated in many locations revealing older layers of paint and stain. The original finish appears to have been a dark brown opaque stain (refer to Photo 14). There are multiple locations, particularly on the lower walls, where small sections of the existing shingles are missing leaving the stud framing of the exterior walls exposed (refer to Photos 12 and 13). These areas should be repaired to prevent further damage to the structure.

Many of the original windows on the north, east, and south façade of the home include wood shutters (refer to Photo 10). The shutters are fixed in place and were intended as a decorative (non-functional)

feature. They are typically comprised of three vertical 1x6 boards with horizontal 1x4 rails at the top and bottom. They are fastened directly to the exterior wall surface without operational hardware. The shutters are generally in good condition but should be repainted, ideally using the original color scheme.

Photo 10: Boarded up living room window on the east elevation. Note the original decorative shutters and shingle cladding.

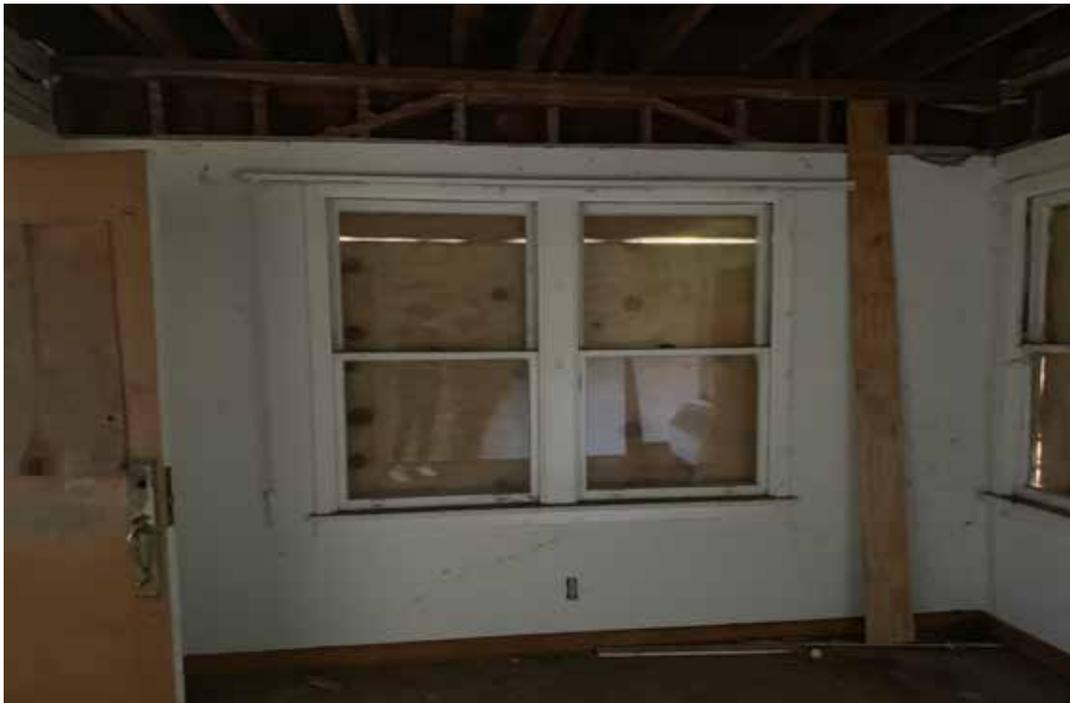
- Type A: One-over-one (1/1) double-hung wood window. These are the most prevalent window type at Quarters D and they are generally located at most rooms on the first floor with the exception of the breakfast room and the two existing bathrooms. They vary in size with larger windows in the primary interior spaces and smaller ones in the kitchen and utility room. Refer to Photo 16.

Photo 16: A pair of Type A (1/1 double-hung) windows on the east wall of the living room.

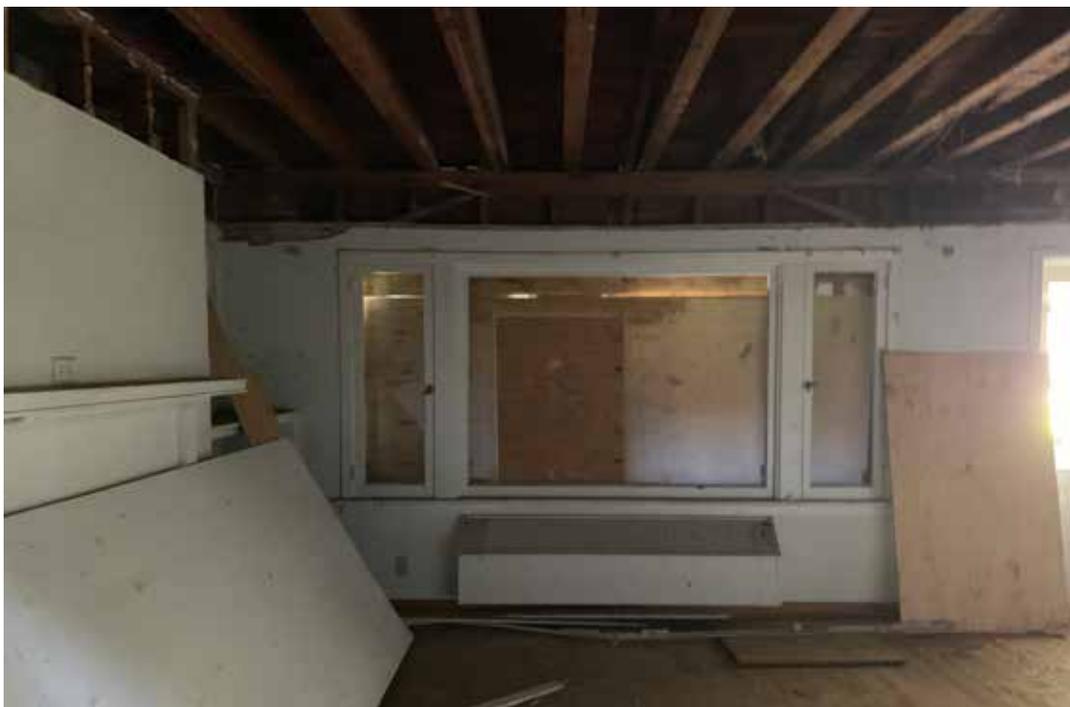
- Type B: Fixed single-light windows. There are two existing historic fixed wood windows, one at the large east-facing window in the living room and the other at the north facing window in the study. In both cases, the fixed sash is flanked on both sides by smaller operable windows. Refer to Photo 17.

Photo 17: A Type B (fixed) window flanked by two type D (casement) windows on the east wall of the living room.

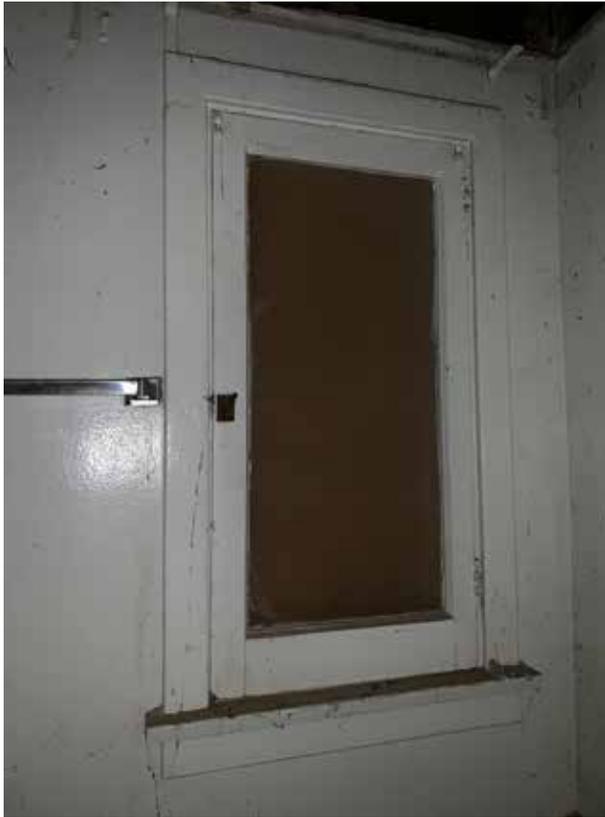
- Type C: Single-light wood casement windows with obscured glass. This window type occurs at all three of the existing bathrooms. Refer to Photo 18.
- Type D: Single-light wood casement windows with clear glass. This window type occurs at bedrooms 2 and 3, the upper hallway, and the living room. Refer to Photo 19. Non-historic single-hung aluminum windows have been added to the second floor bedroom windows and the original wood framed screens have been removed. Future rehabilitation should include the removal of the non-historic aluminum inserts and replication of the original screens at all casement windows.

Photo 18: A Type C (casement with obscured glass) in bathroom 1.

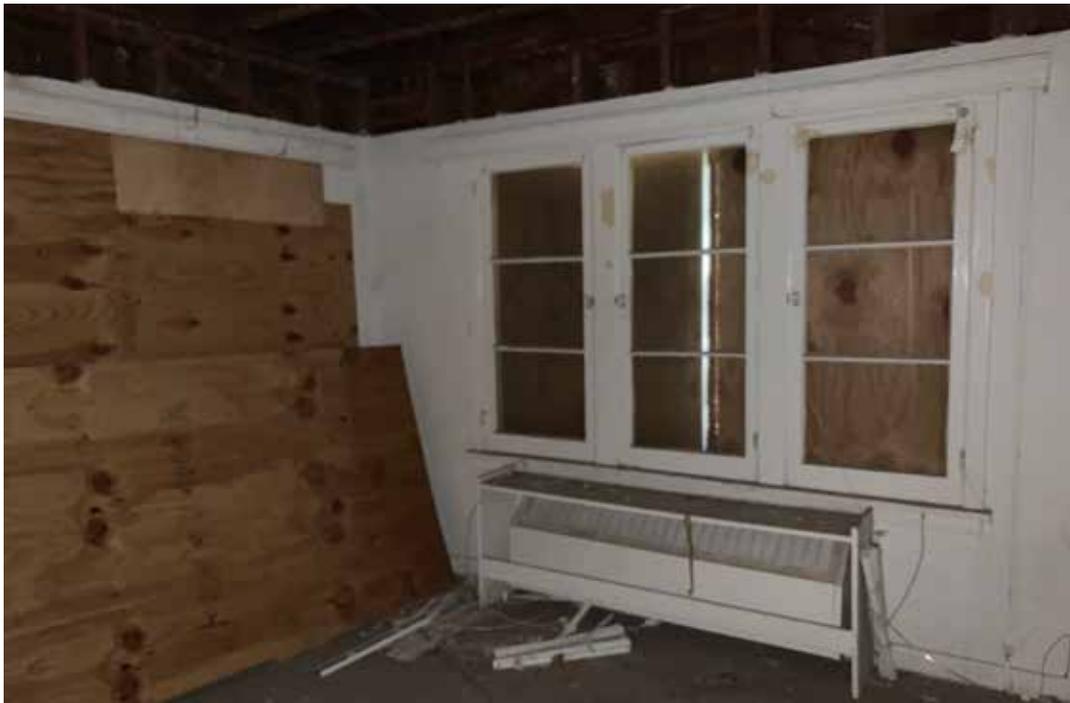
- Type E: Three-light wood casement windows. This window type occurs at the breakfast room which features two sets of three, three-light casement windows. Refer to Photo 20.

Photo 20: Three Type E (three-light casement) windows on the north wall of the breakfast room.

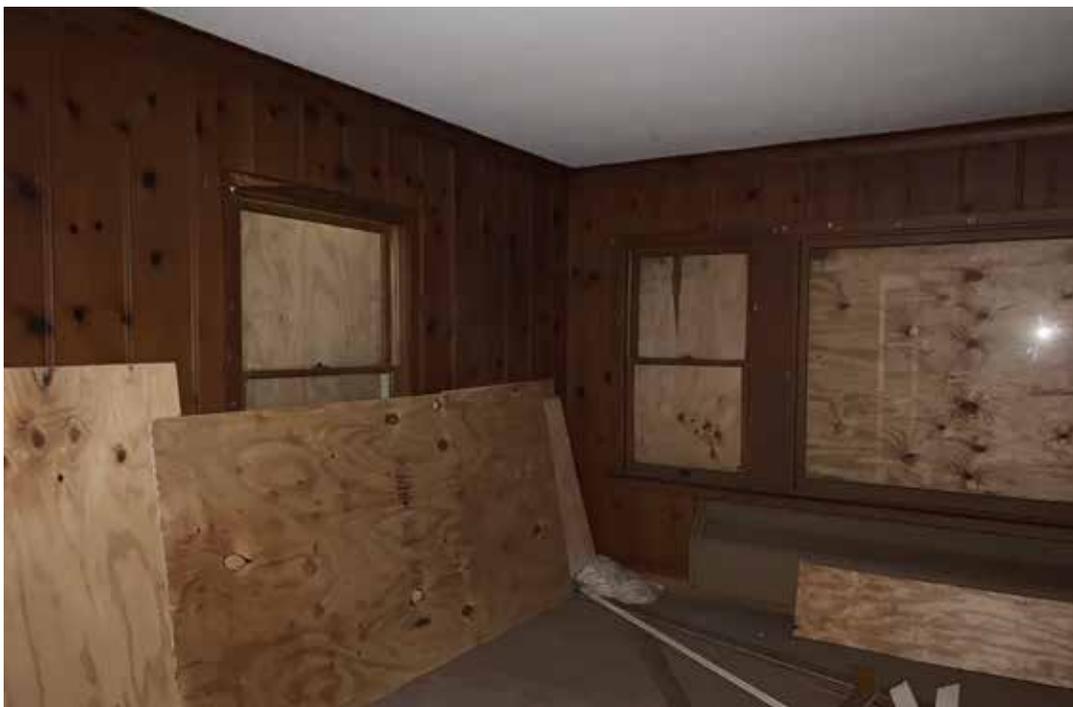
Study: (refer to Photo 25) This room appears to have been altered, possibly 1950s era.

Photo 25: The study looking northwest. Wood paneling has been added on the walls.

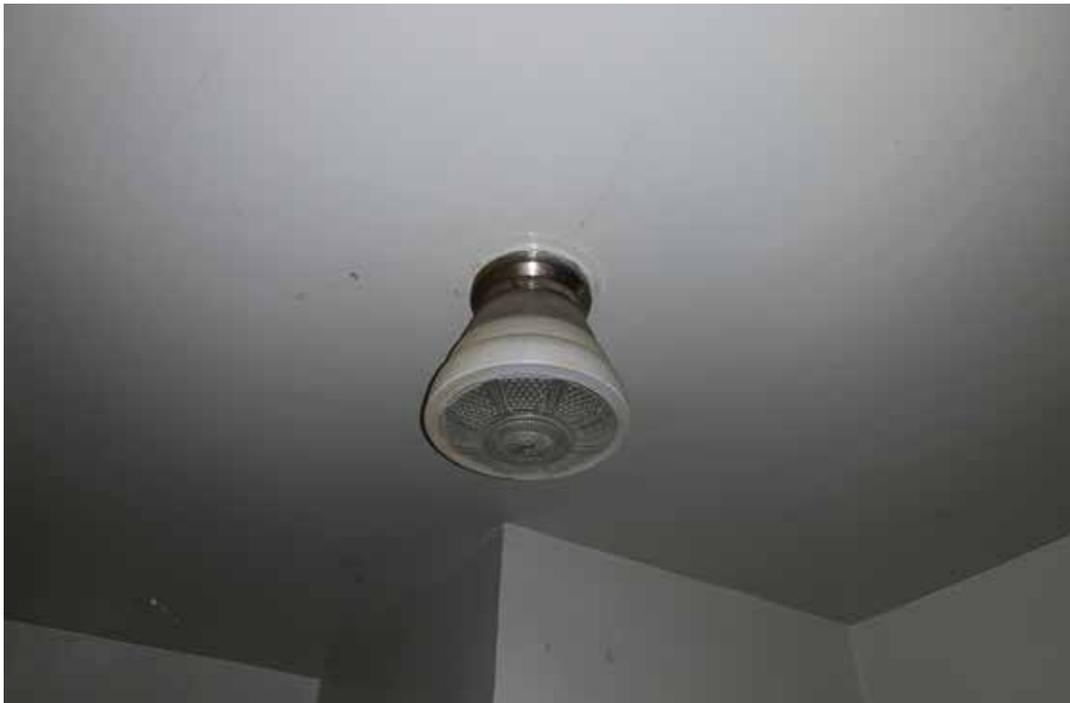
Most of the existing interior light fixtures have been removed along with the ceiling finishes on the first floor. There is one period-style ceiling mounted light fixture in the utility room that may be historic (refer to Photo 28). Other remaining light fixtures in the study, and the second floor bedrooms and bath appear to be non-historic dating from approximately the 1950s or later.

Photo 28: A period-style light fixture in the utility room.

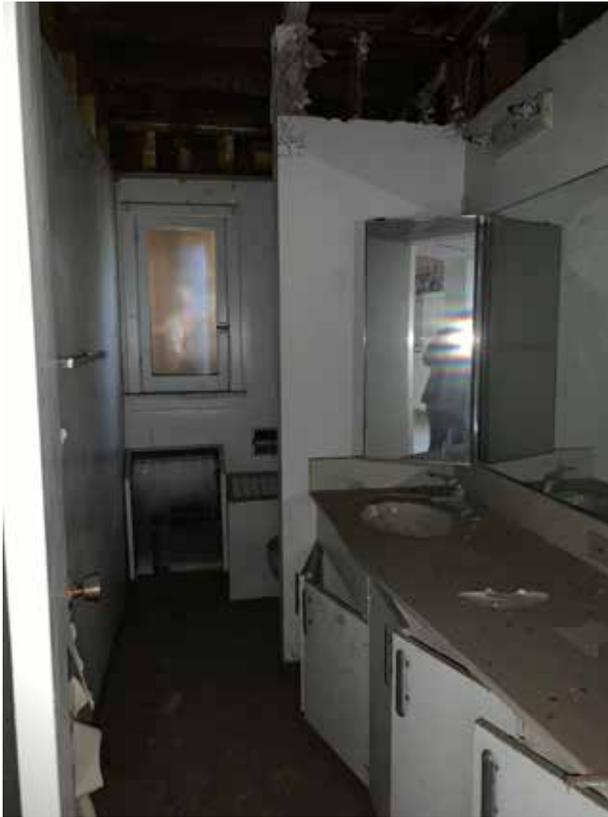
Photo 30: Bathroom 1 looking south. The vanity, fixtures, and cabinet are non-historic.

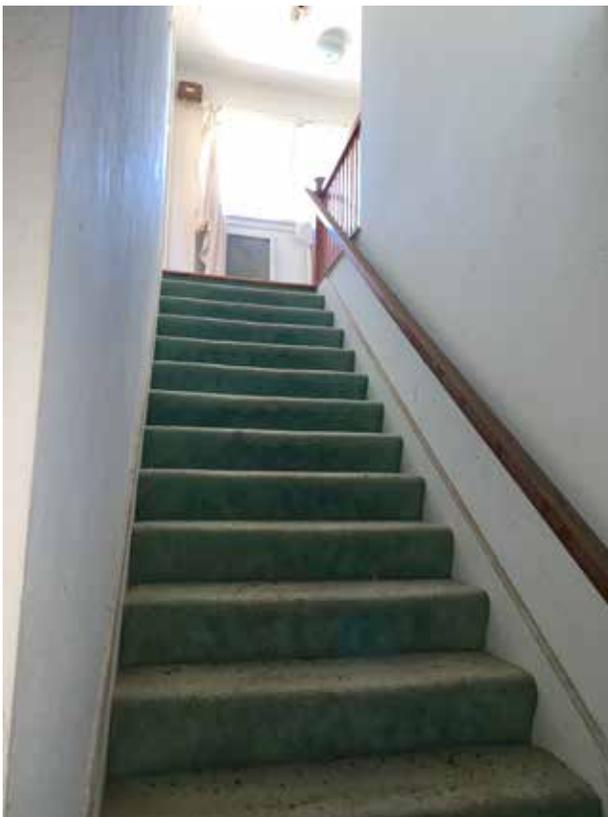
The original wood floors remain in many of the interior rooms including the living room, dining room, study, halls, and bedrooms (refer to Photos 22-24, 34-36, and 39-40). In general, the original wood flooring is in fair condition with some deterioration and water staining. Future rehabilitation efforts should include refinishing existing wood flooring. Non-historic VCT and resilient sheet flooring have been added in the kitchen, breakfast room, utility room, and all three bathrooms. This resilient flooring and VCT is generally in poor condition and it should be replaced. Non-historic carpet has been added on the stairs. The carpet is poor condition and it should be replaced.

Photo 31: The stairs looking west toward the second floor. Non-historic carpet has been added.

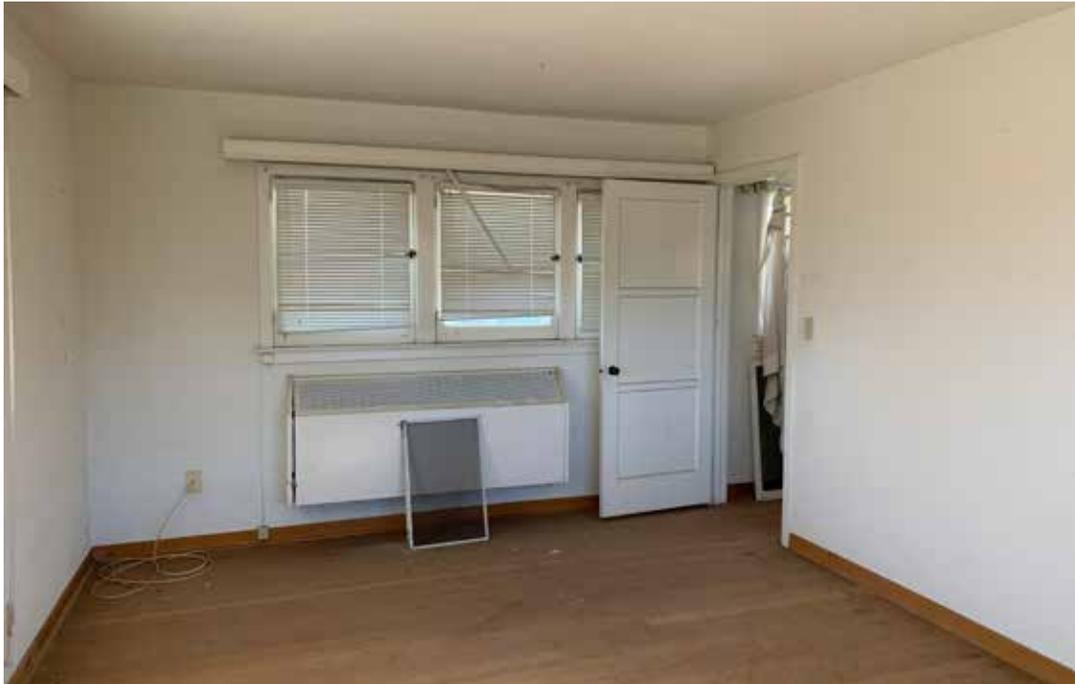
Photo 34: Bedroom 2 looking west. Original interior doors, wood flooring, and plaster wall and ceiling finish remain.

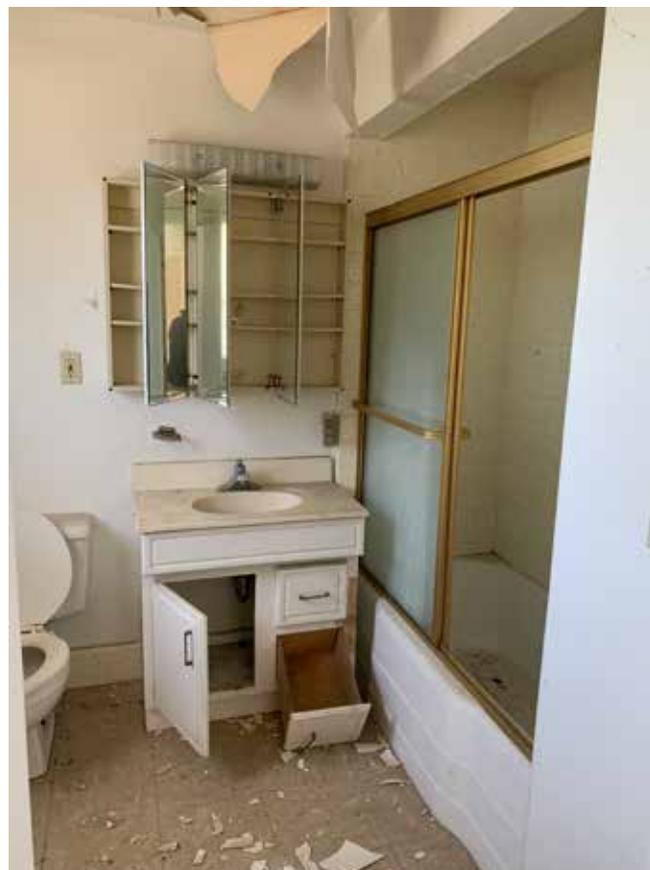
Photo 37: Bathroom 3. Existing fixtures and cabinetry are non-historic.

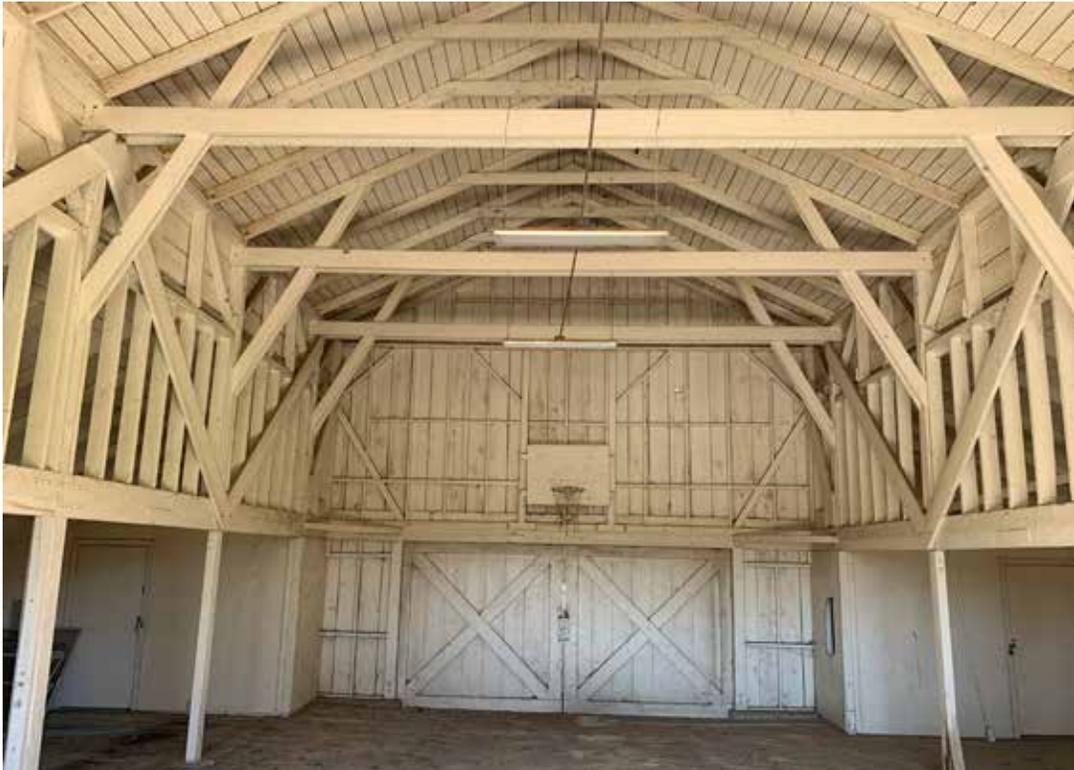
Photo 42: The interior of the barn looking north. The original timber framing remains in good condition.

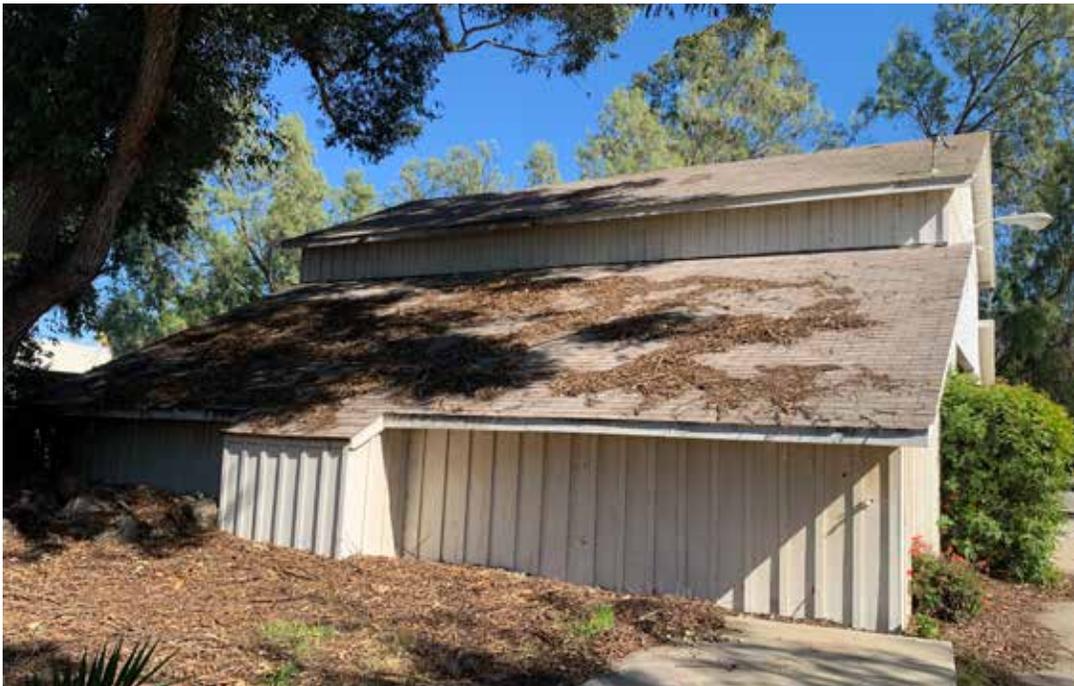
Photo 43: The barn looking east toward the roof and exterior board-and-batten siding. The siding appears to be in good condition.

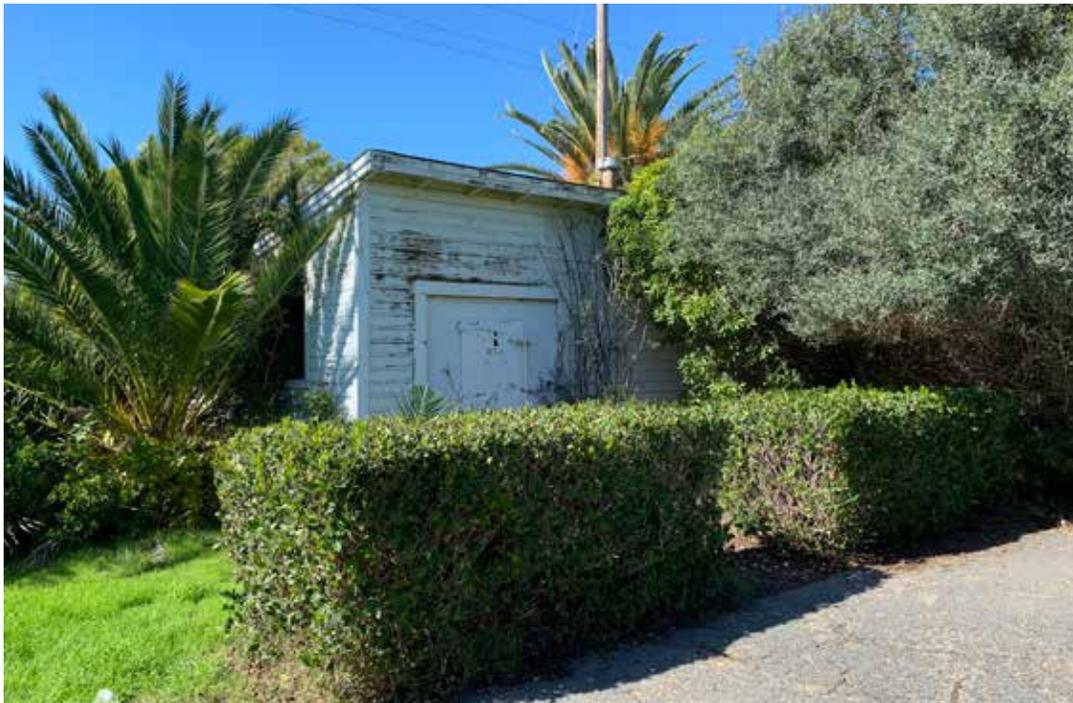
Photo 44: The east elevation of the milk house. This structure has been determined non-contributing and it will be demolished.

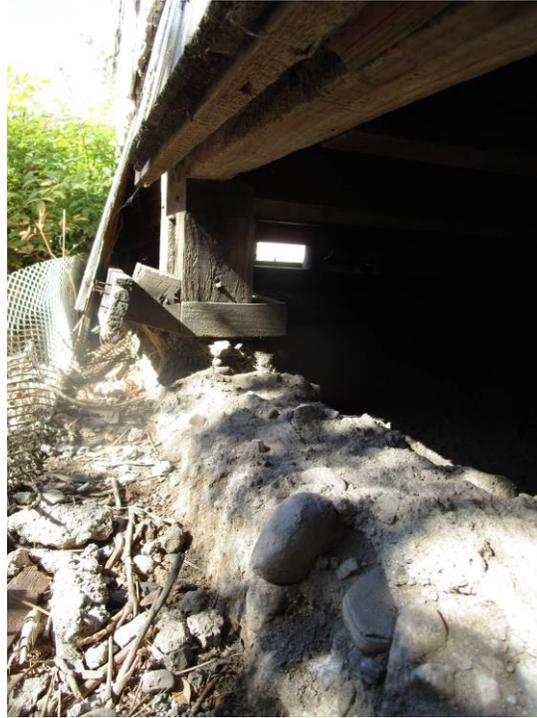
**Photo 3 – Perimeter Footing and Sill Plate**

The quarters D dwelling is raised off grade with 9" tall 2x4 cripple walls supported on a 7" wide continuous cobble aggregate concrete footing at the perimeter and isolated intermittent concrete piers at the interior (Photo 3,4).

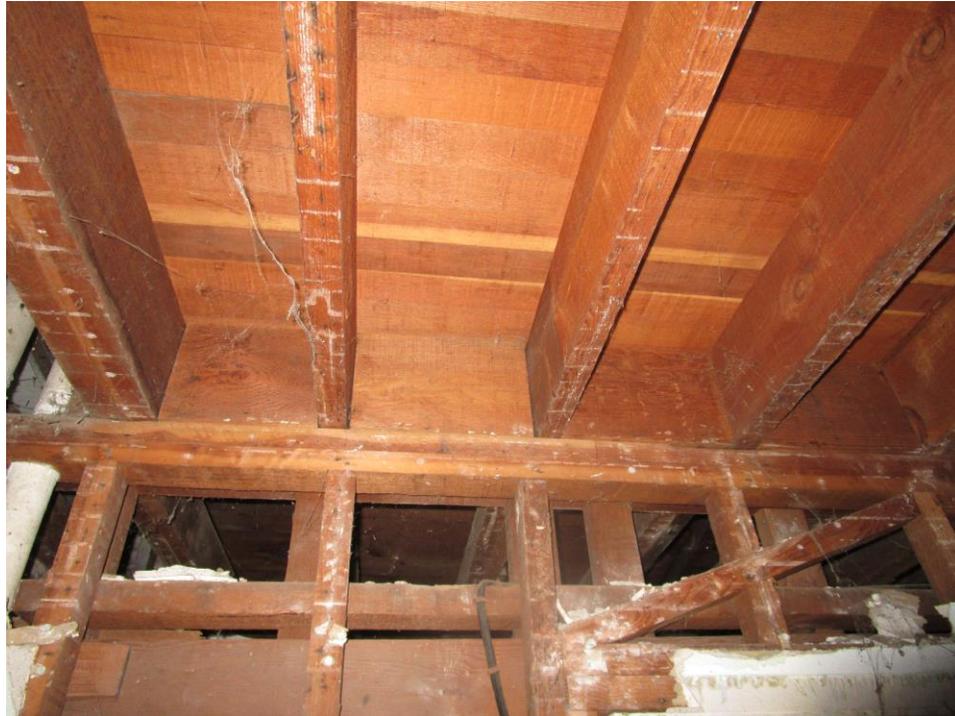
**Photo 5 – 2<sup>nd</sup> Floor Framing**

The first floor is constructed of 2x8 wood joists at 16" on center spanning in the north-south direction and covered with diagonal sheathing on top. The second floor is constructed of 2x10 wood joists at 16" on center spanning in the east-west direction and covered with straight sheathing on top

(Photo 5). The low roof framing covering the single-story portions of the residence is constructed of 2x4 rafters at 32" on center covered with straight sheathing. The high roof framing covering the second story was not exposed for observation.

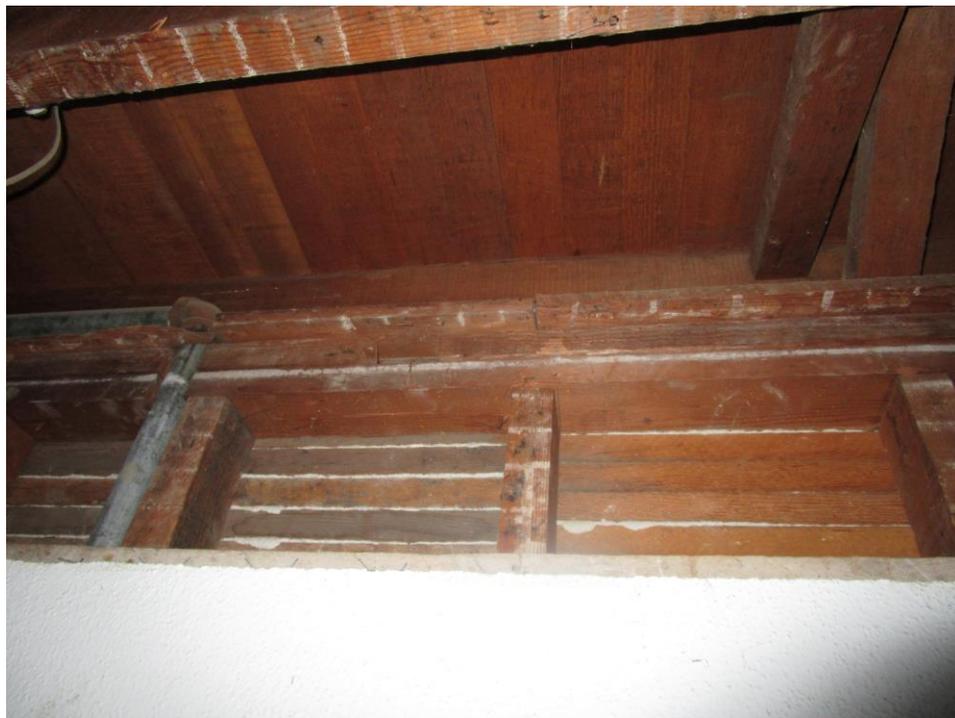
**Photo 6 – Interior Lath and Plaster**

Walls are constructed of 2x4 studs spaced at 16" on center. Perimeter walls are sheathed with wood shingle siding on the exterior and covered with wood lath and plaster on the interior (Photo 6, 7).

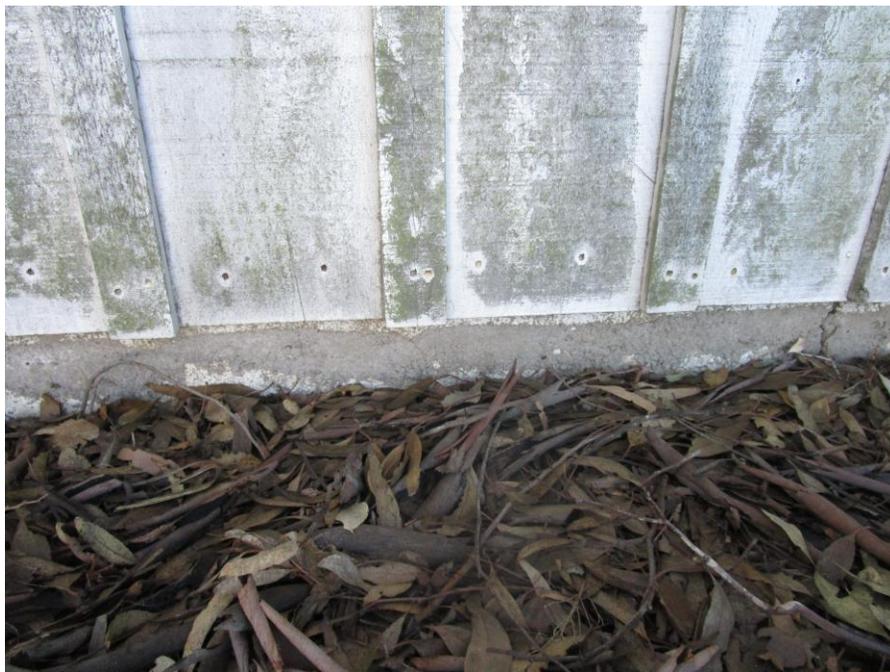
**Photo 8 – Slab on Grade Foundation at Barn**

The barn is supported on a concrete slab on grade foundation (Photo 8). The interior of the barn was fenced off and inaccessible, thus framing member dimensions were not recorded. The roof of the barn is constructed of rafters with collar ties spanning in the east-west direction at approximately 32" on center sheathed with straight sheathing on top (Photo 9). The high roof is supported on a post and beam system, the posts continue to the slab on grade foundation and create a column grid within the barn. The low roof is supported by the internal column grid and the north-south wood stud walls. The exterior of the barn is covered with board and batten (Photo 10).

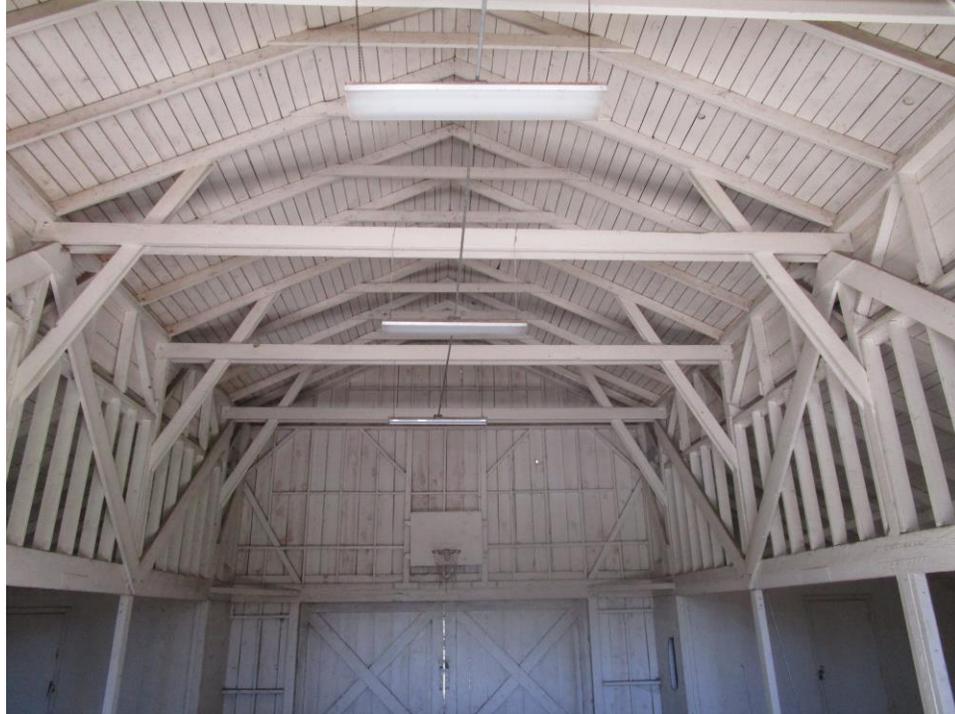
**Photo 9 – Interior view of Barn framing**

The barn framing appears to be in generally good condition from what could be observed. An interior post was observed to have sustained some impact (Photo 21).

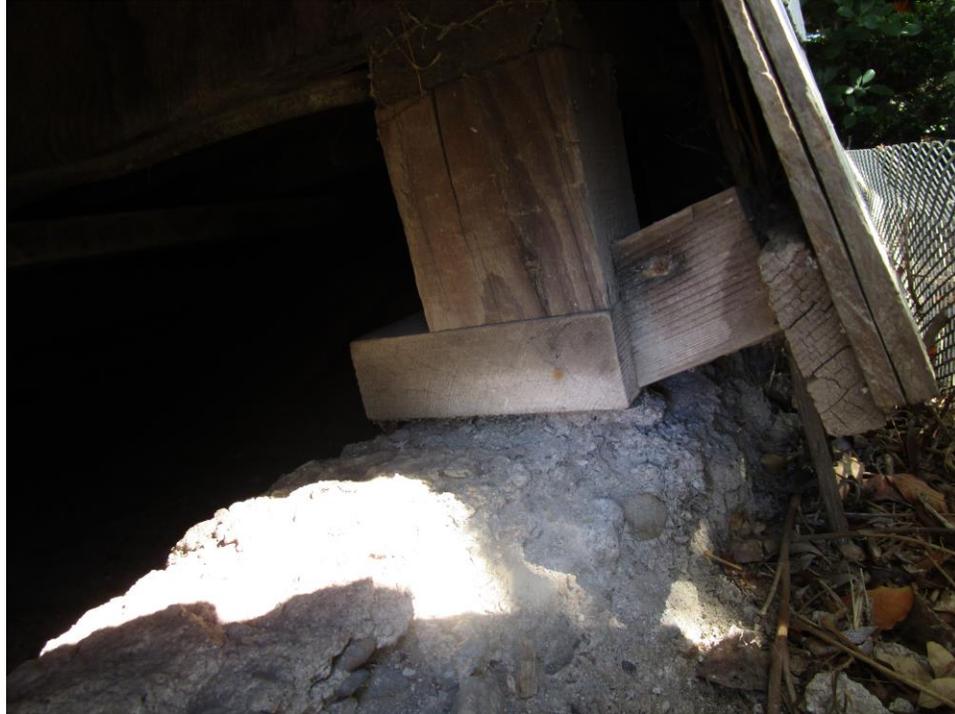
**Photo 11 – Close up of sill plate on footing**

Sill plate, siding and posts in close proximity to grade do not show extensive signs of decay or rotting (Photo 11, 12).

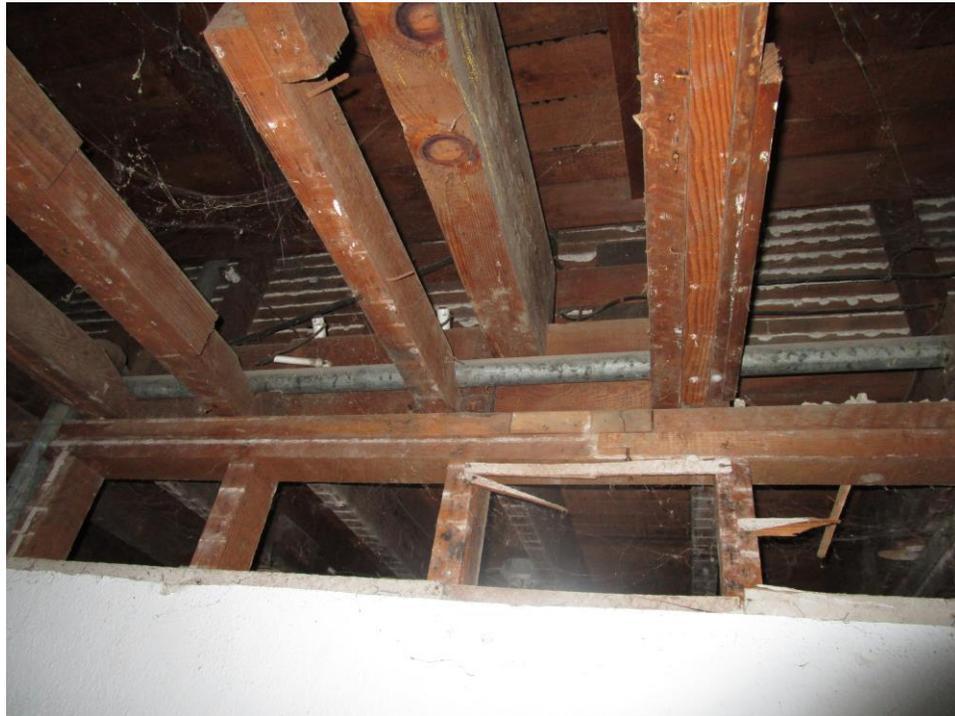
**Photo 15 – Close up of discontinuous lath and plaster**

The lath and plaster was observed to have been systematically removed from approximately the top 12" of the walls at all locations (Photo 14, 15).

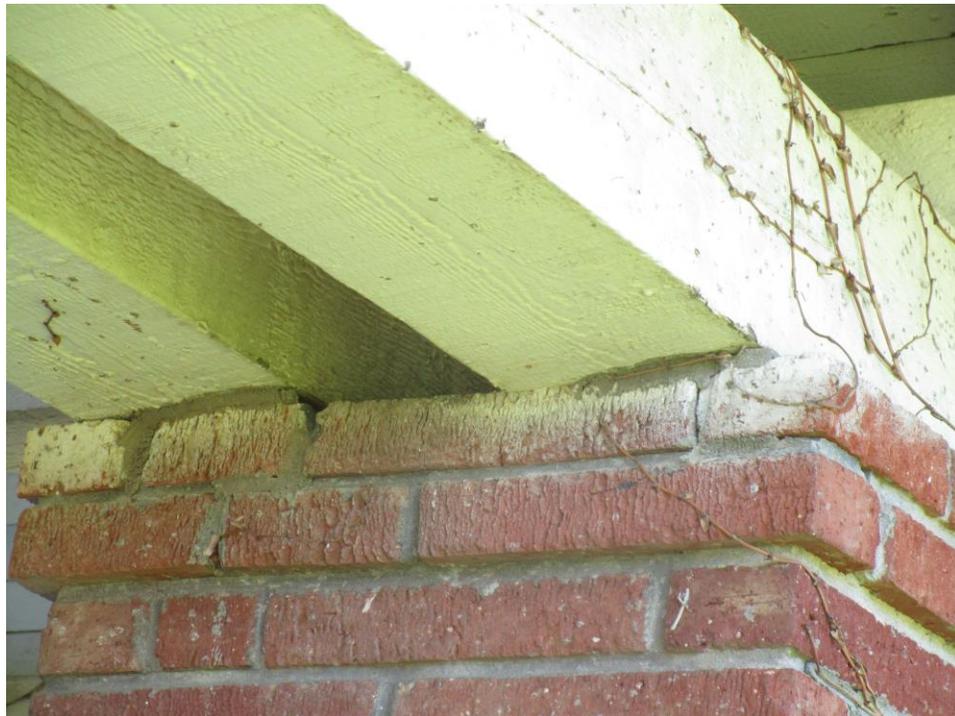
**Photo 16 – Close up dry pack below rotated beam**

Exterior porch beams appear to have warped and twisted some time ago and have currently been dry packed over existing unreinforced brick pilasters (Photo 16). The grout of the unreinforced brick pilasters shows signs of deterioration and one brick is absent near the base. Ornamental faux beams may have inadequate support, the toe nail connection of one has failed and the beam was found on the ground (Photo 17). Due to the painted outline it is likely it was attached to the brick chimney (Photo 18). Other faux beams were determined to have similar susceptible connections (Photo 19).

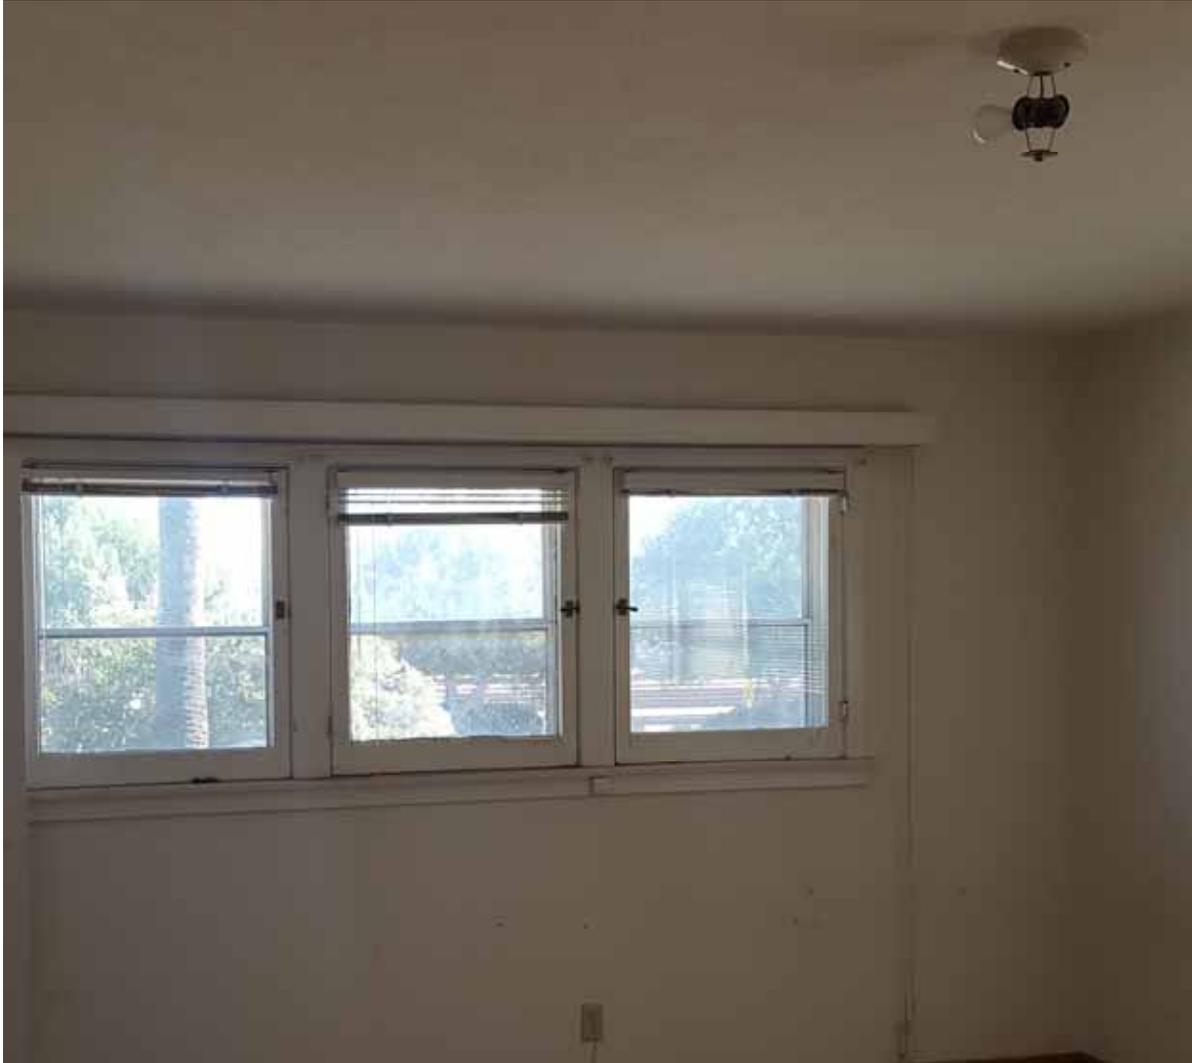
Bedroom incandescent lighting fixture without the shade/diffuser.
